HISTORIC STRUCTURE REPORT

FOR CHARLES THOMPSON MEMORIAL HALL
1824 MARSHALL AVENUE | ST. PAUL, MN 55104

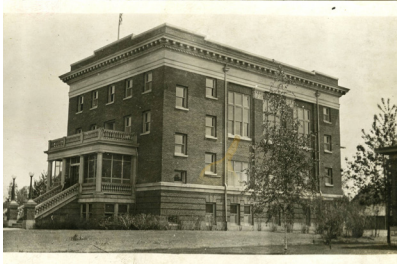
1916 photograph of the northwest corner of Charles Thompson Memorial Hall, showing the numerous and large windows. Courtesy of the Minnesota Historical Society.

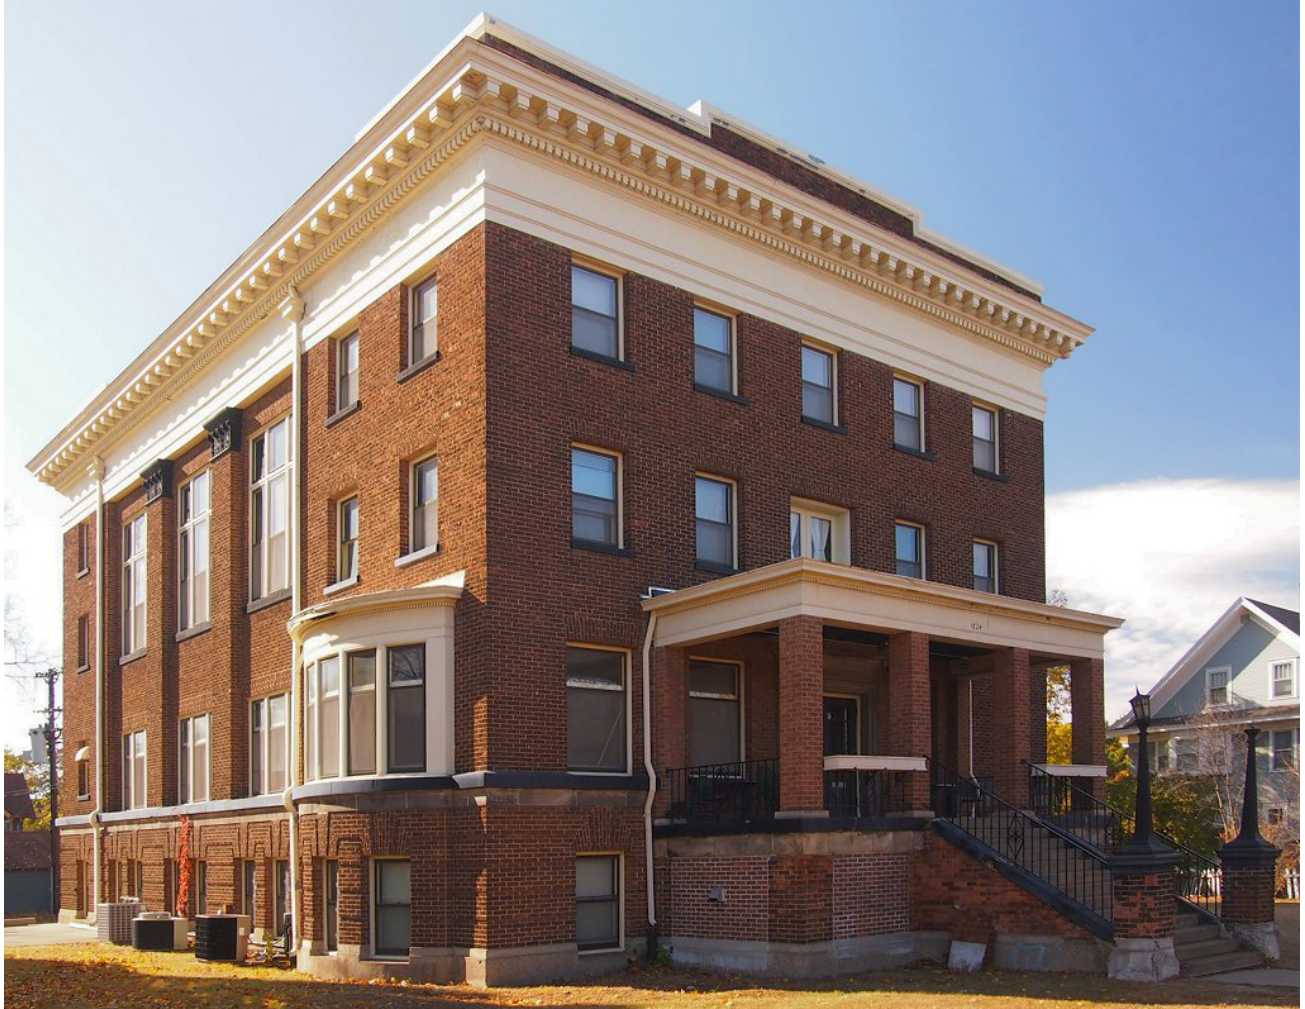
View of the northeast corner of Charles Thompson Memorial Hall.

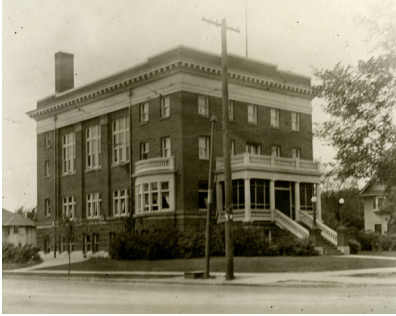
Photograph of the exterior of the building showing original columns. Taken circa 1925-29.

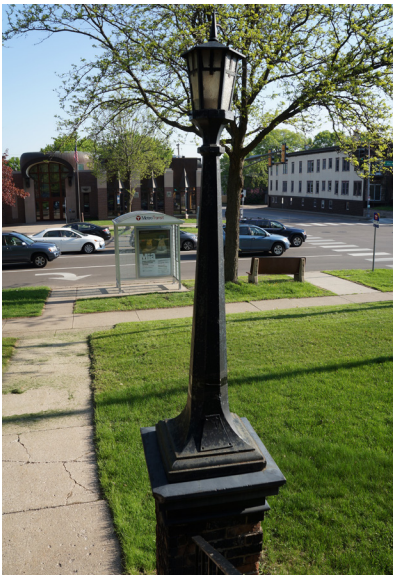
Lamp post at the edge of the porch stairs.

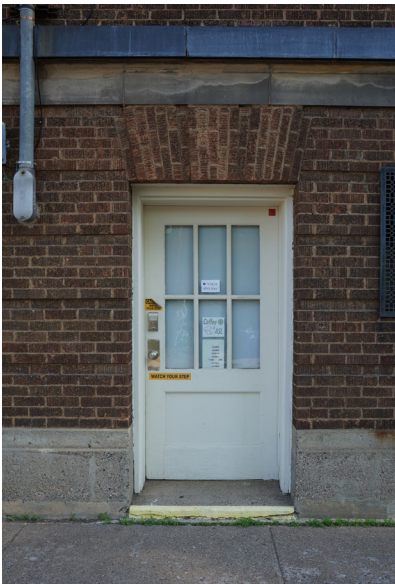
South entrance door.

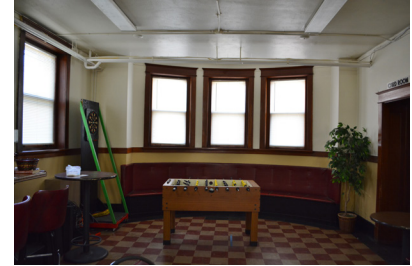
East side of the basement with the bow window.

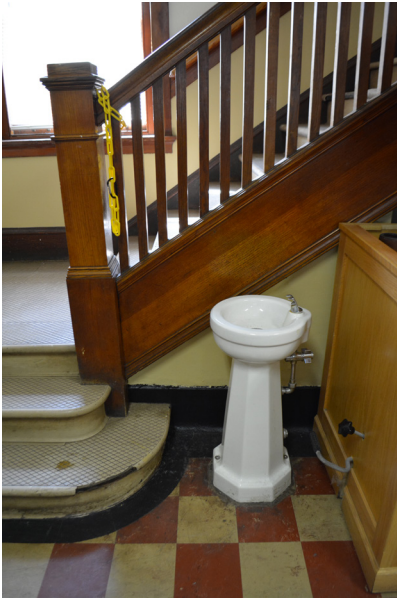
Drinking fountain by the front stairs in the basement.

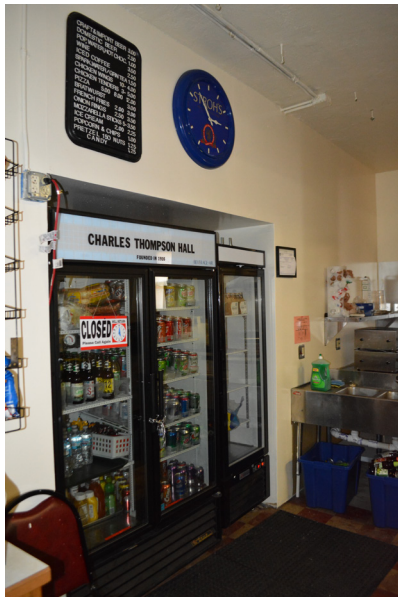
Refrigerated display cases in the cavity beneath the exterior stairs.

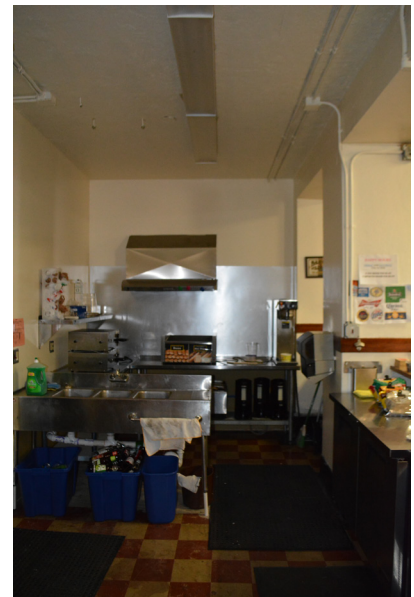
Kitchen equipment, photograph facing east.

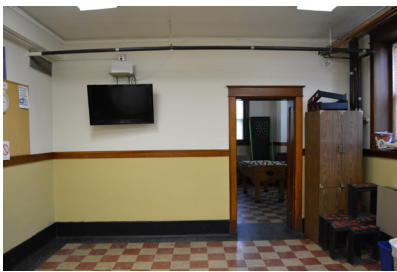
Card room, facing west.

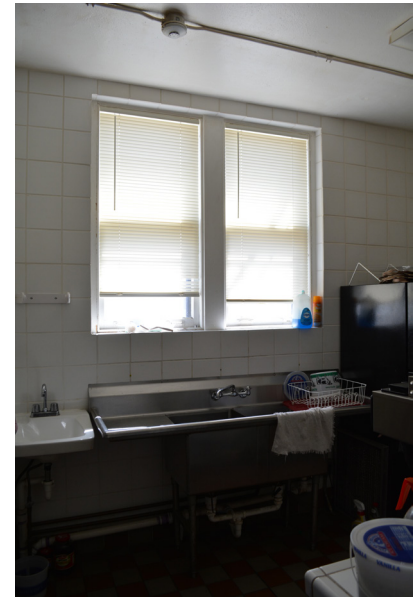
Kitchen sink and south windows.

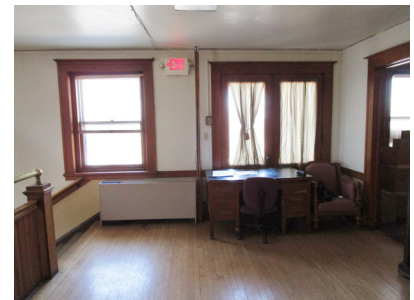
Second floor lobby, photograph facing south.

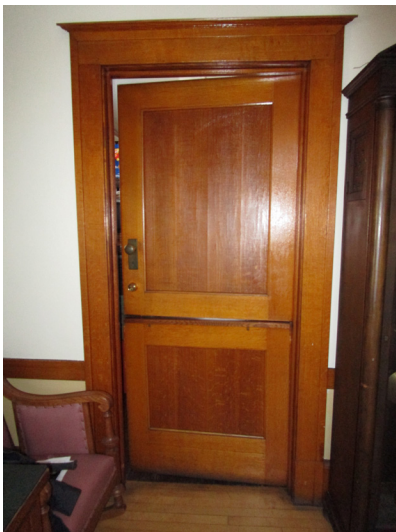
Dutch door to the coat room.

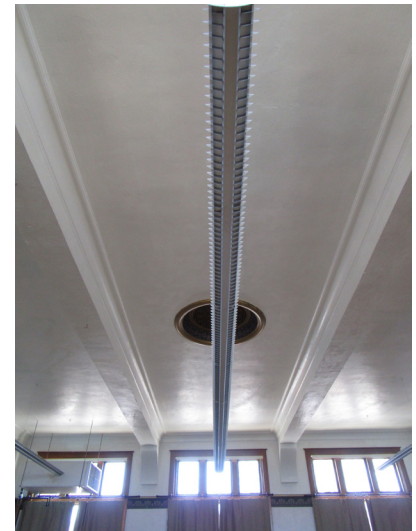
Ceiling in the assembly hall, photograph showing circular vent, plastered wood beams, and florescent lights.

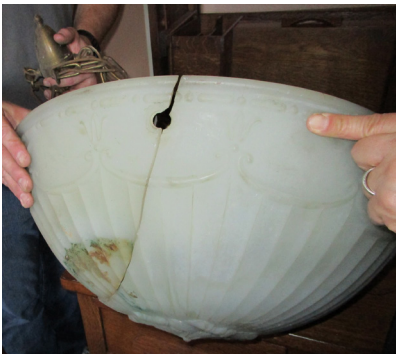
Photograph of the original assembly hall light fixture found in the attic.

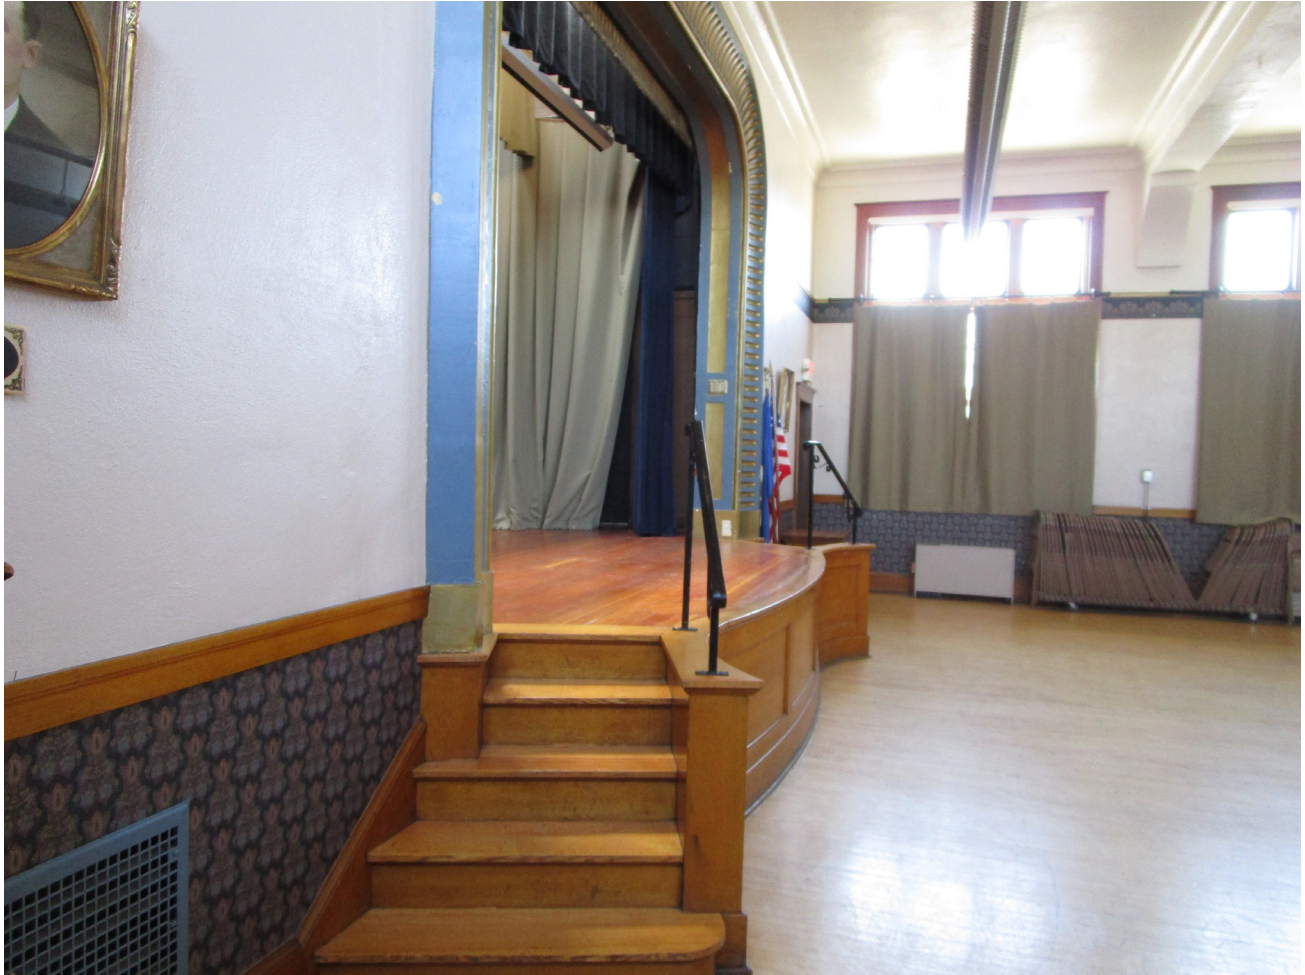
Side view of the assembly hall stage.

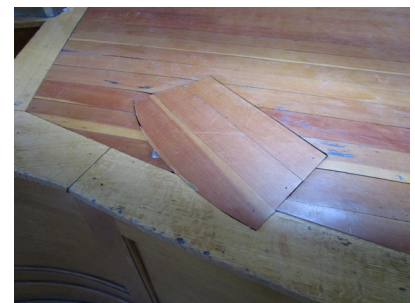
Floor section at the edge of the stage where lights were originally located.

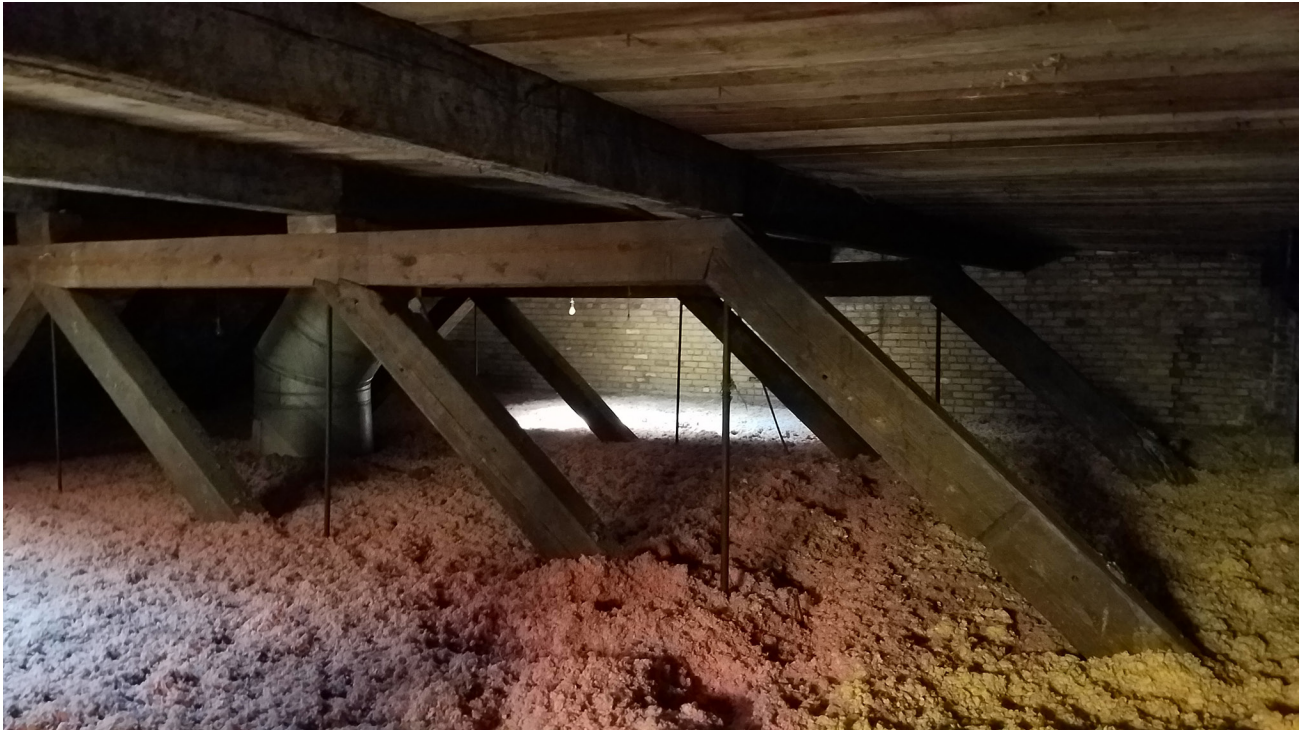
Attic, showing wood trusses and loose fill insulation.

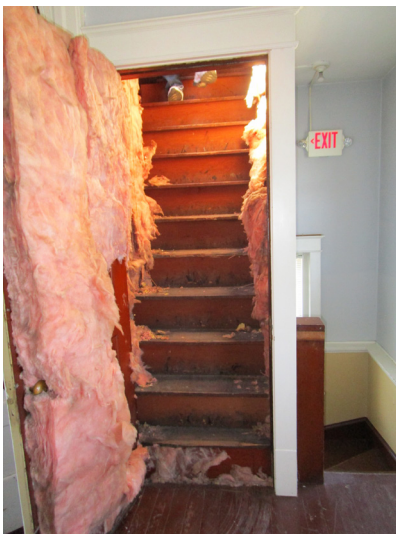
Stairway to the attic from the third floor hallway.

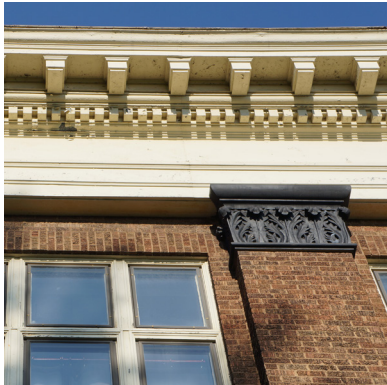
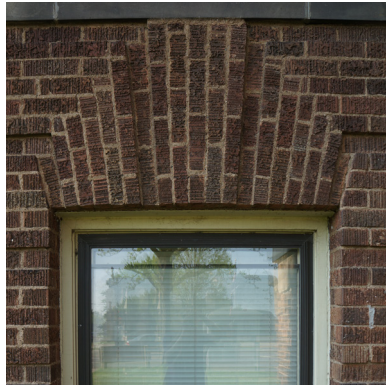
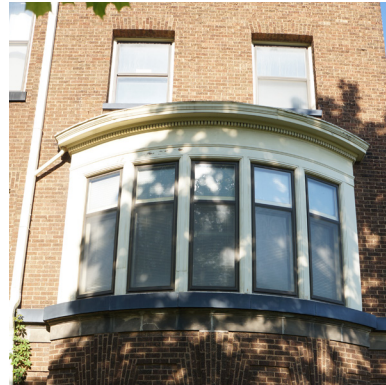
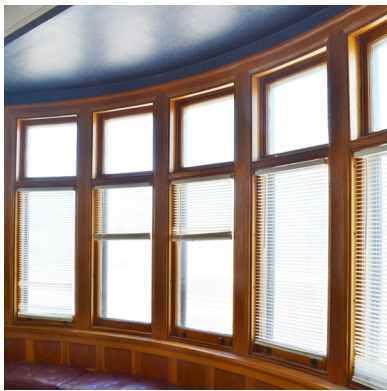
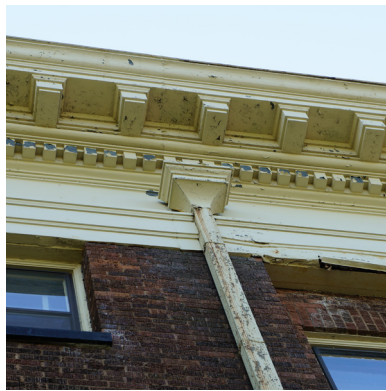
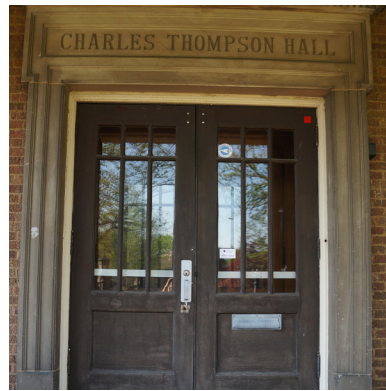
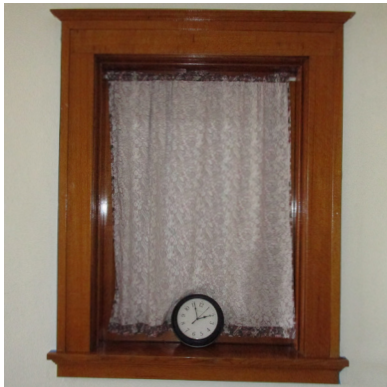
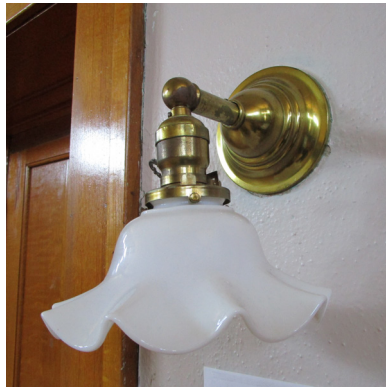
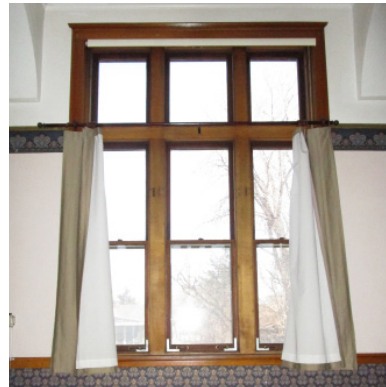
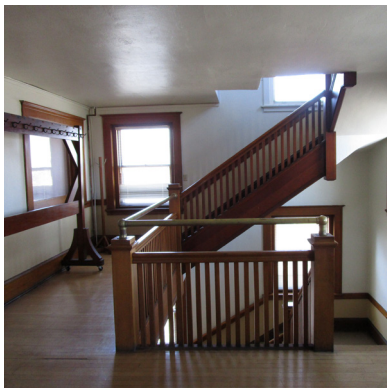
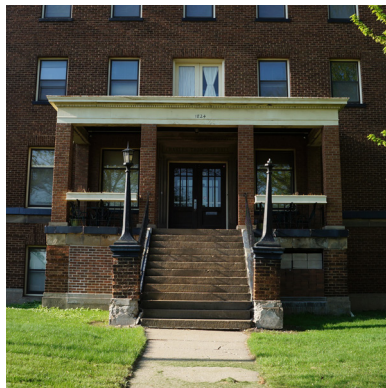
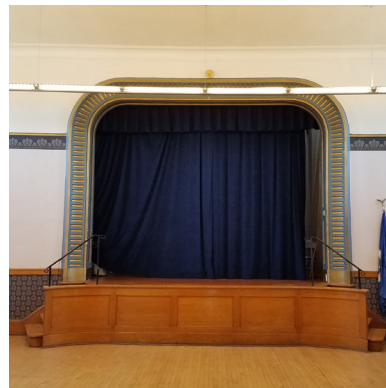
CHARACTER-DEFINING FEATURES

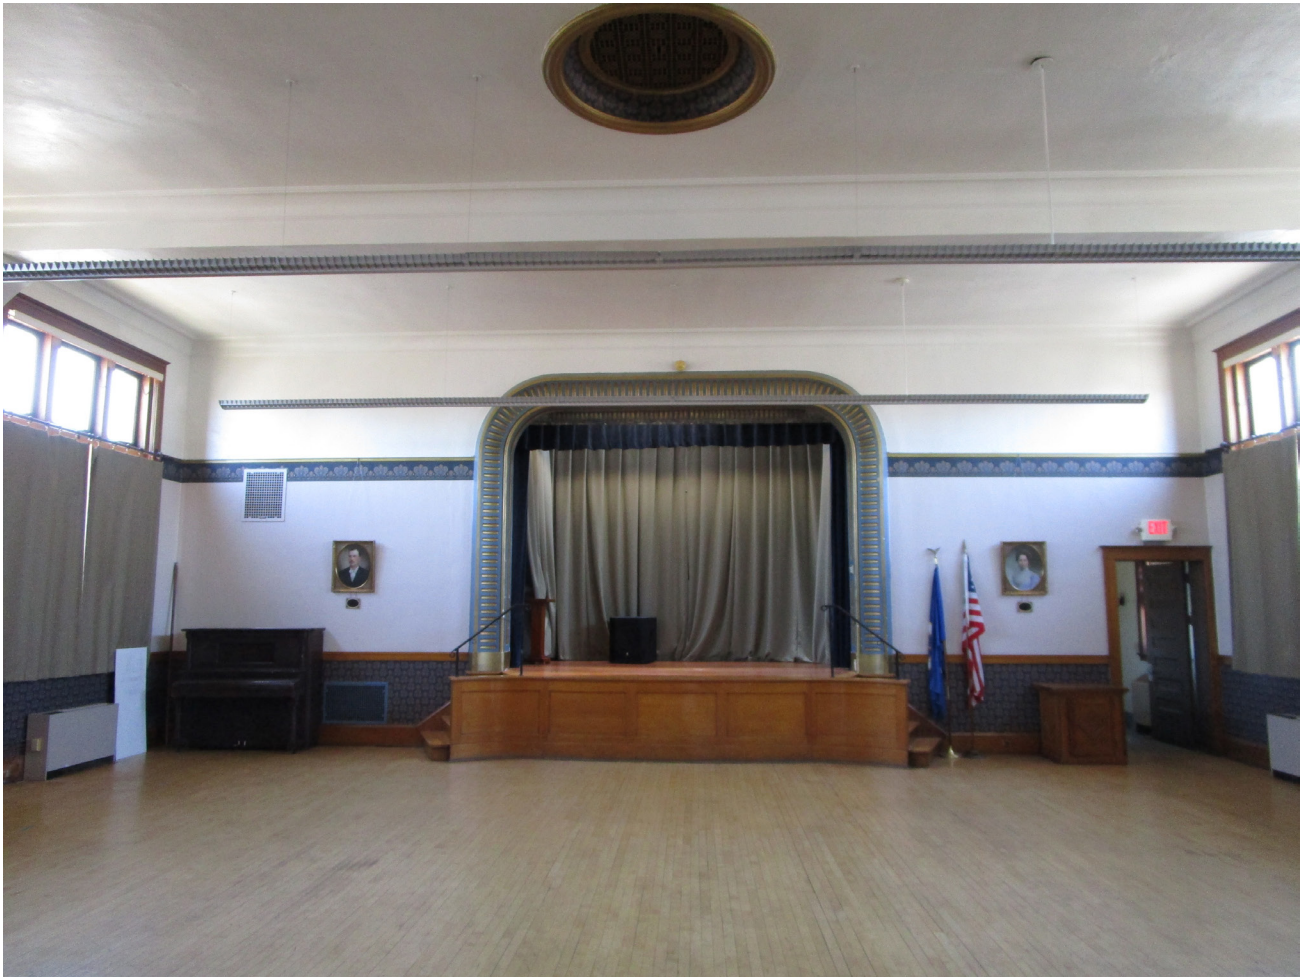
The large, double-height Assembly Hall is a primary space. Its significance is due to its use as a large gathering space, and its configuration and volume should therefore be retained.

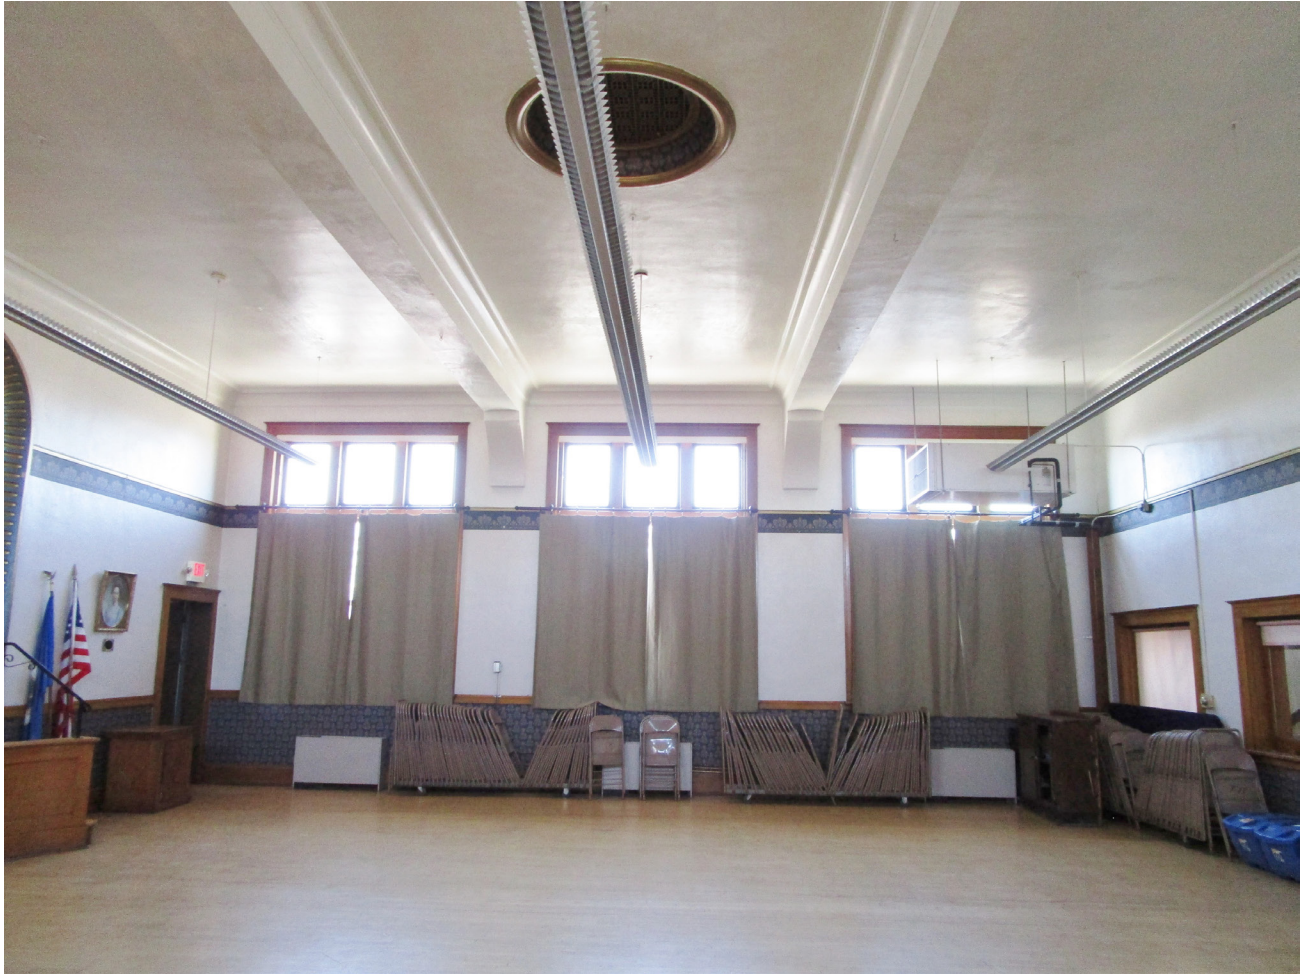
View of the Assembly Hall's large ceiling beams and windows, facing east.

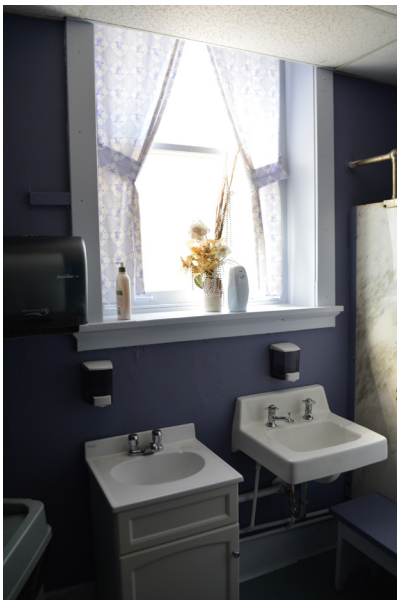
Sinks in the women's toilet room that are not compliant with ADA standards.

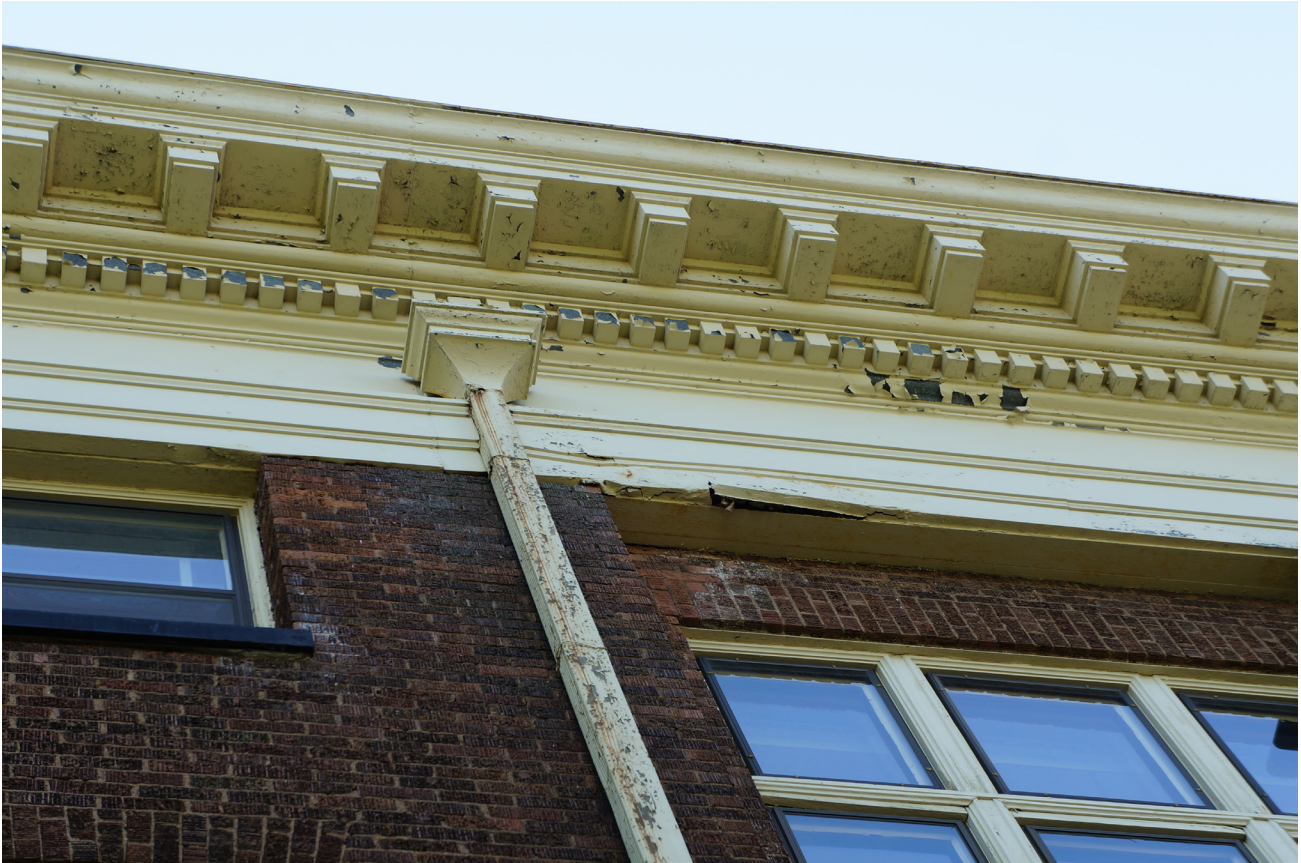
North downspout on the west facade of the building, showing corrosion, loose seams, peeling paint, and damage to the surrounding masonry.

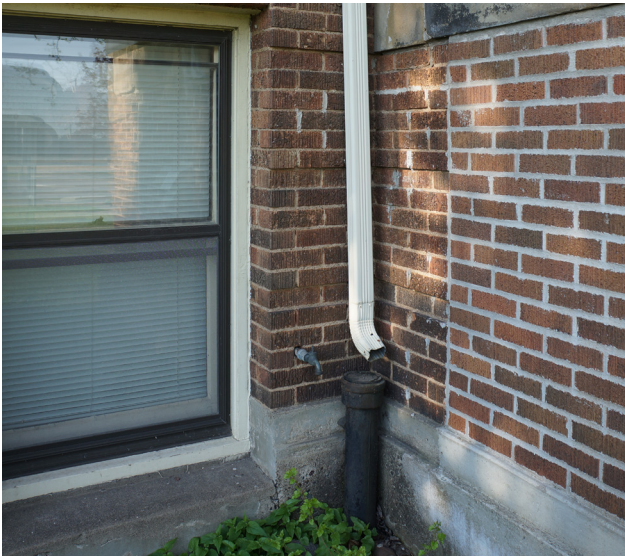
Short downspout on the east side of the porch.

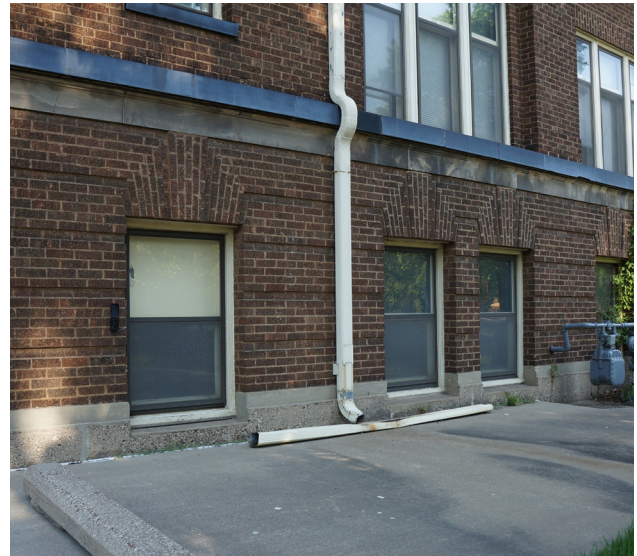
South downspout on the east facade.

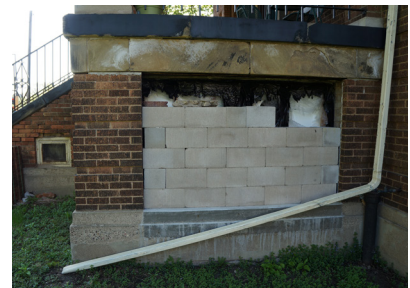
Downspout at the west side of the north porch that dumps water too close to the building.

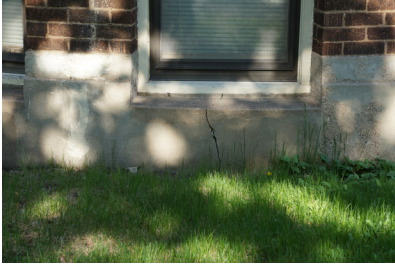
Vertical crack in the concrete below the center opening in the bow window.

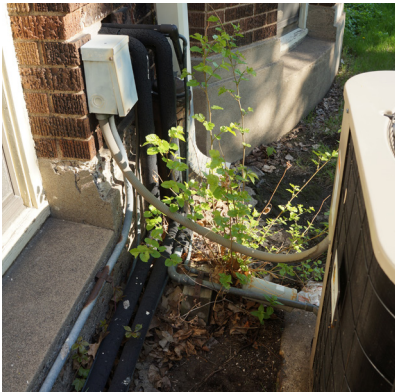
Concrete cracking near pipe penetrations on the east facade.

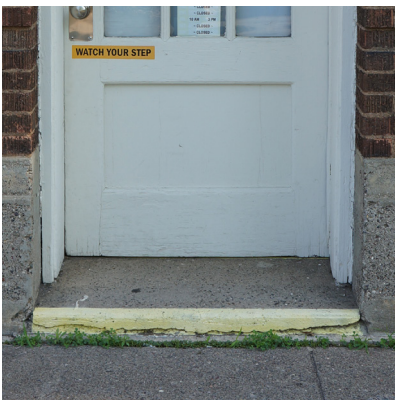
Horizontal crack in concrete in south door sill.

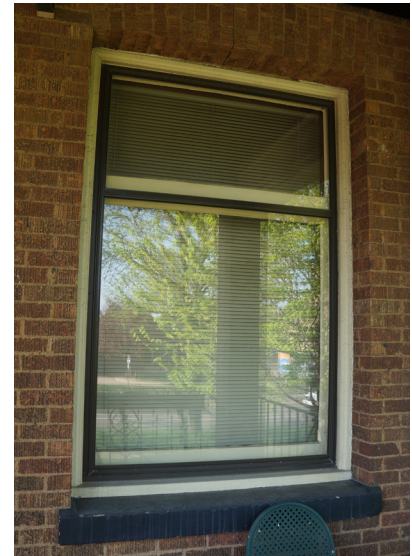
Cast stone sill at east side of porch.

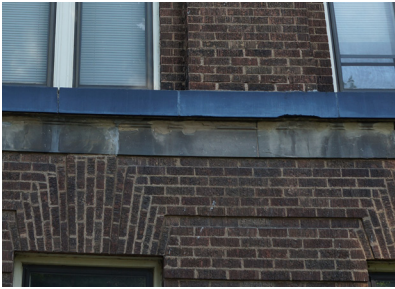
Chip out of cast stone water table on east facade.

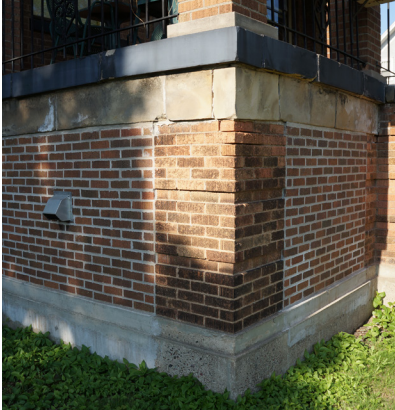
East porch openings that have been infilled with brick.

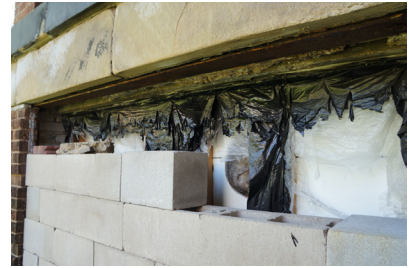
Partially completed infill of opening below porch.

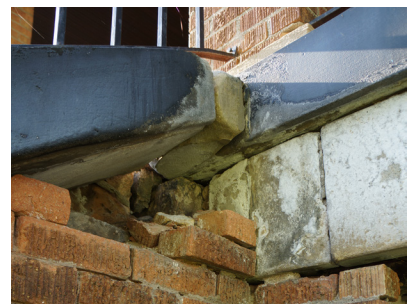
Missing brick below the cast stone cap at the top of the porch stairs' west wing wall.

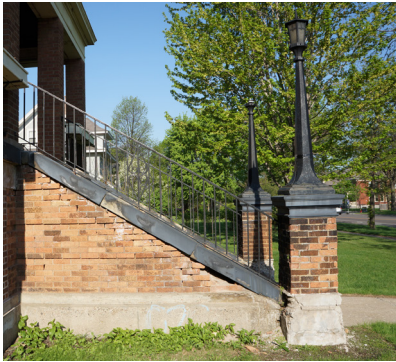
Masonry deterioration at the east wing wall of the porch stairs.

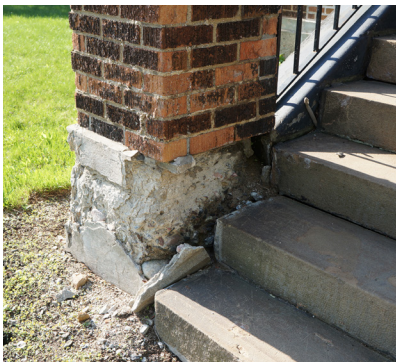
Concrete deterioration at the base of the east post of the porch stairs.

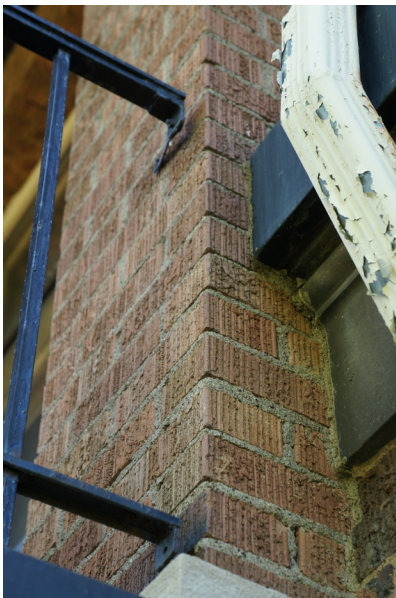
Metal guard rail that has become detached from the brick masonry.

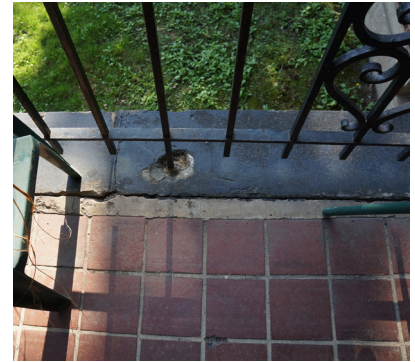
Large grout joint between cast stone and quarry tile floor at east edge of the porch.

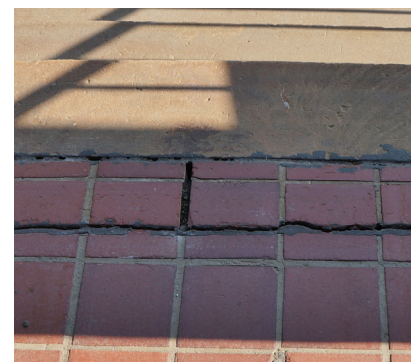
Crack through quarry tiles at north edge of porch.

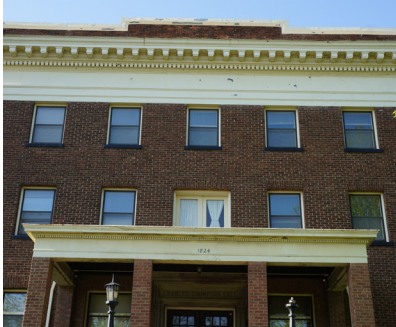
North porch cornice showing deterioration and missing balustrade.

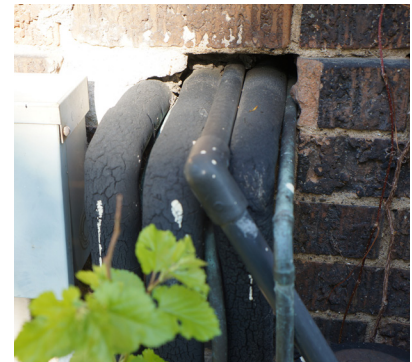
Pipe penetrations in brick at east facade.

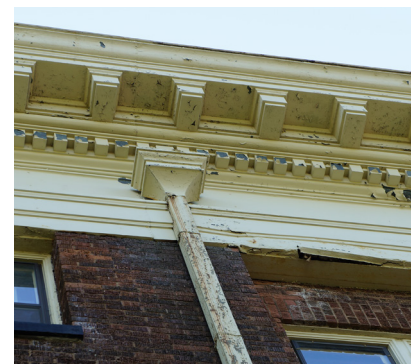
Black stains and efflorescence on the brick surrounding the north downspout on the west elevation.

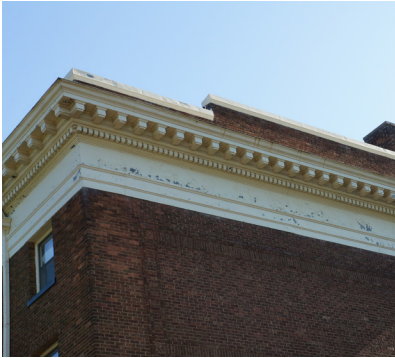
Black stains and efflorescence on the brick beneath entablature on south side of building.

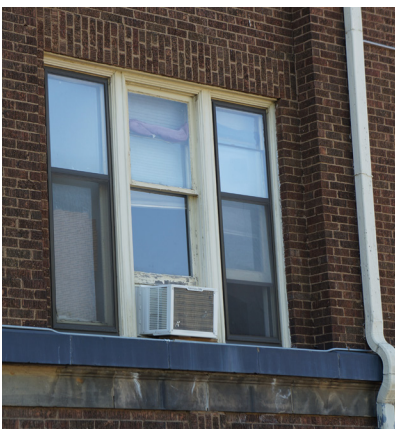
Window air conditioner unit at south side of first floor apartment on west facade.

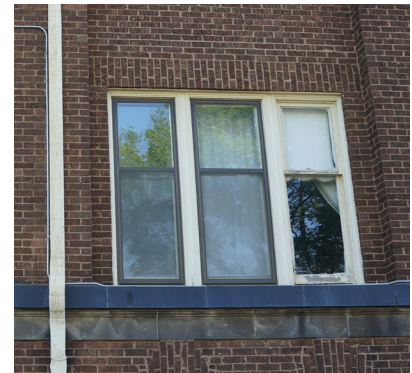
Missing storm window near north side of west facade at the first floor.

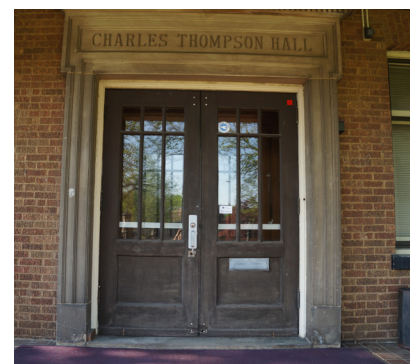
North entrance doors beneath porch.

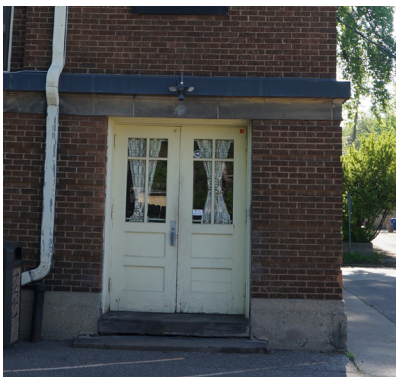
West entrance doors.

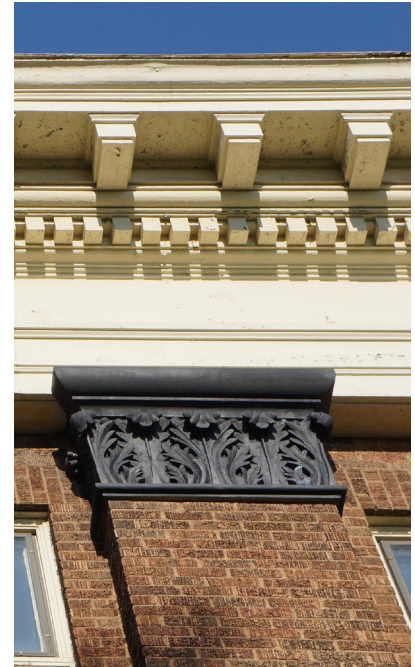
Terra Cotta Cornithian capital and Entablature on west side of building.

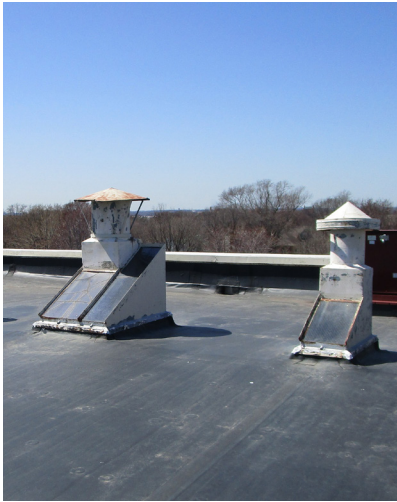
Skylights at north side of roof.

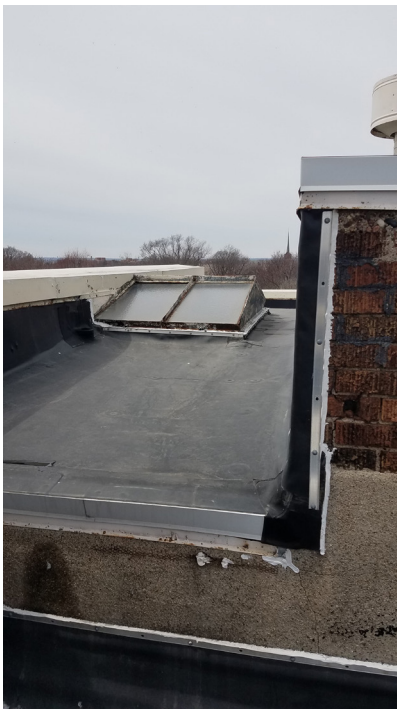
The elevated portion of the roof over the stage has several condition issues, including the membrane itself, the parapet coping, and the skylight.

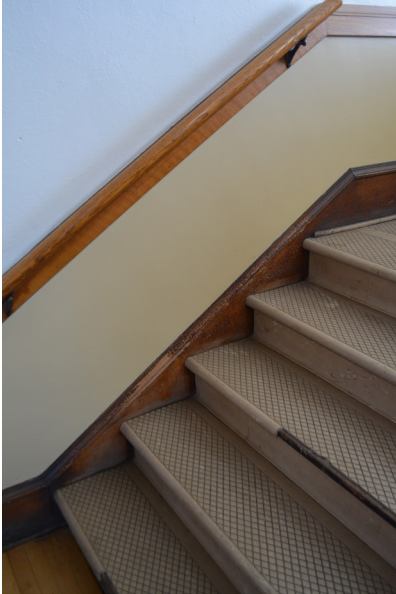
Photograph showing chips in nosing of front stair, deteriorated finish at wall stringer trim, and inadequate handrail extension.

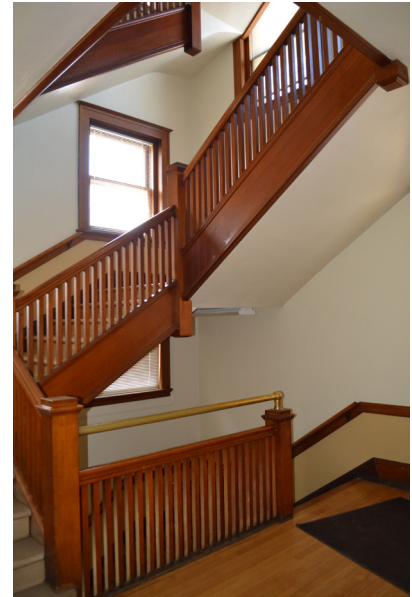
Photograph of front stair at first floor lobby. The bottom of the wood guardrail is stained.

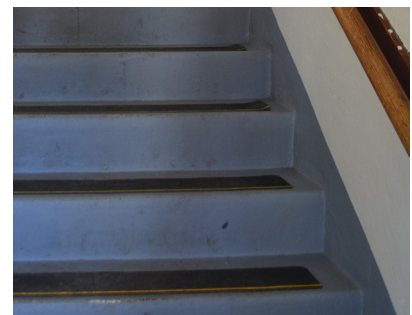
Adhesive treads on stairs between the exterior door and the landing to the apartment.

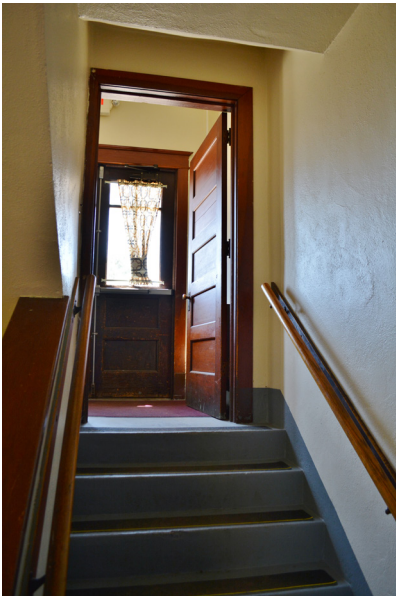
Photograph from the bottom of the back stairs looking towards the door at the top of the stairs.

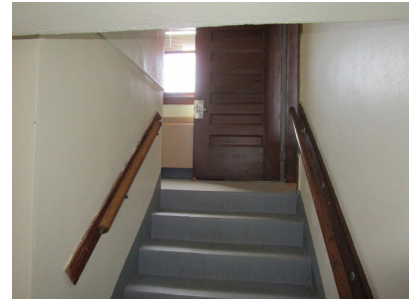
Door to the assembly hall at the top of the back stairs.

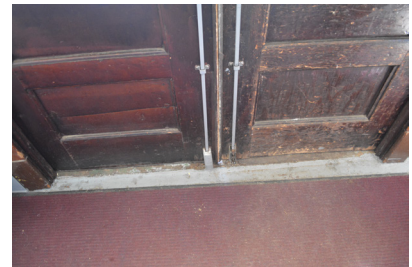
Missing cover at the bottom of the west entry door panic bars.

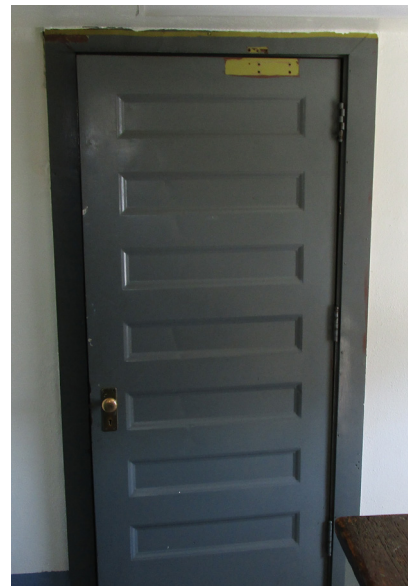
Missing closer at first floor door from back stair.

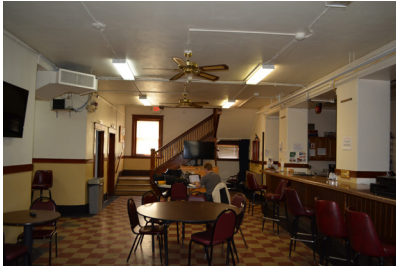
Basement lobby/assembly area.

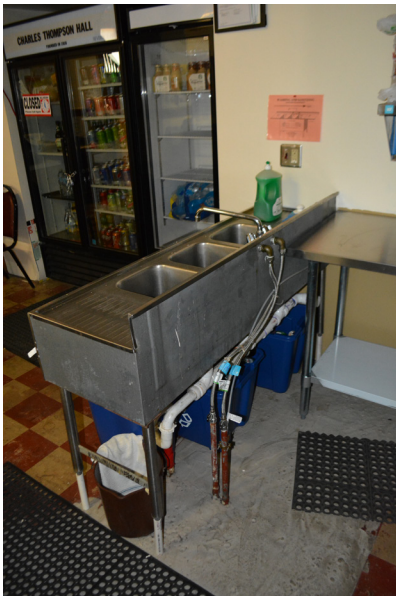
Condition of floor beneath the kitchen sink.

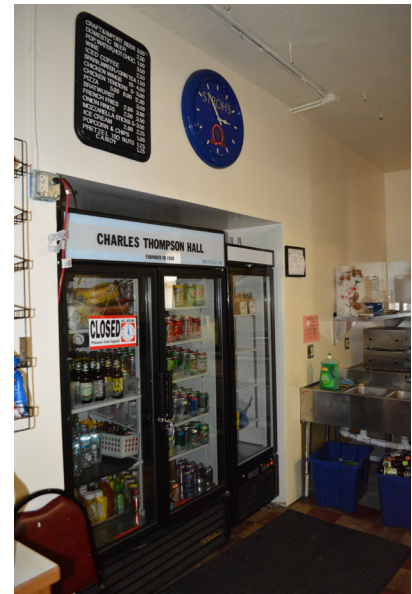
Refrigerated display cases in the space beneath the front exterior stairs.

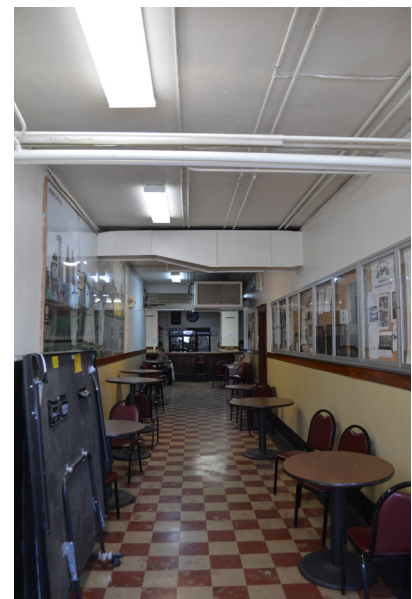
Main hallway in basement.

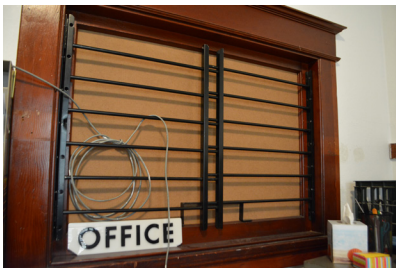
"Office" sign and boarded up window with metal bars in Committee Room.

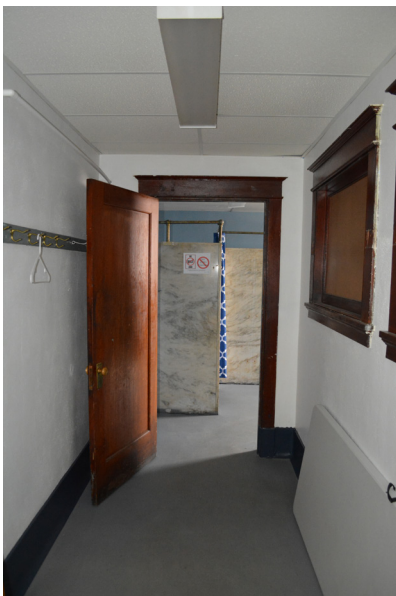
Passage showing boarded up interior windows between Committee Room and Men's Toilet Room.

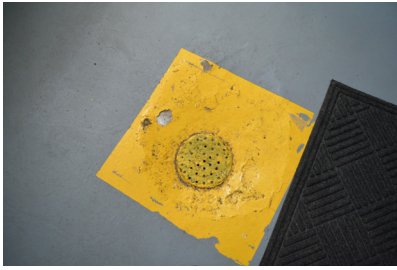
Floor drain in Women's Toilet Room.

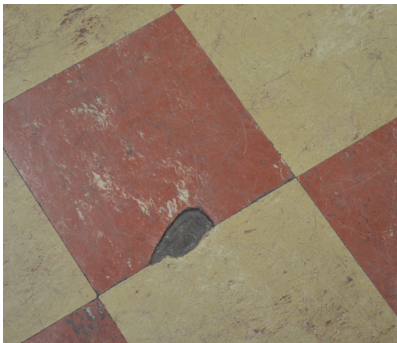
Chipped vinyl asbestos floor tile in the Card Room.

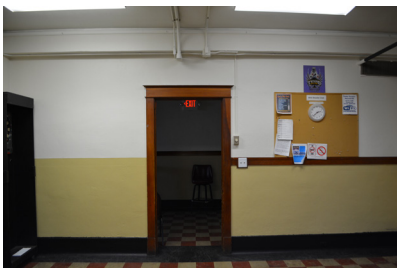
Missing trim to the left of the door to the main hallway in the Card Room.

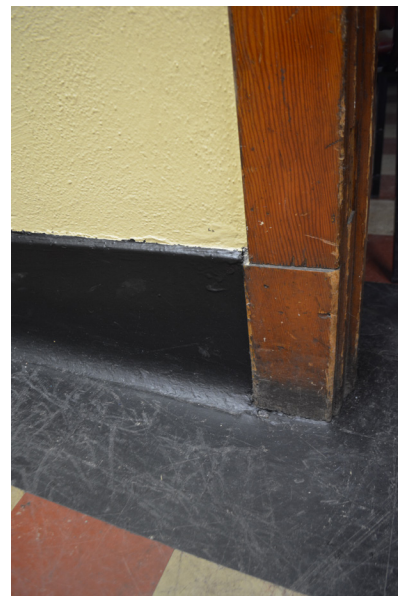
Discolored bottom of door casing in the basement Card Room.

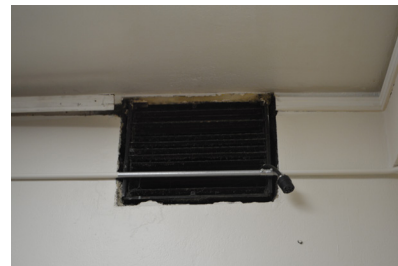
Missing vent cover in Card Room.

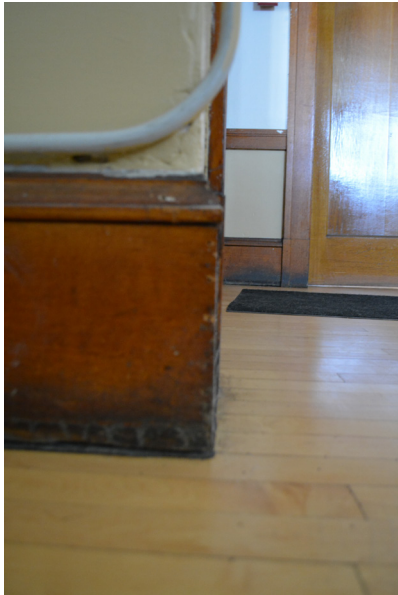
Discolored baseboard in first floor lobby.

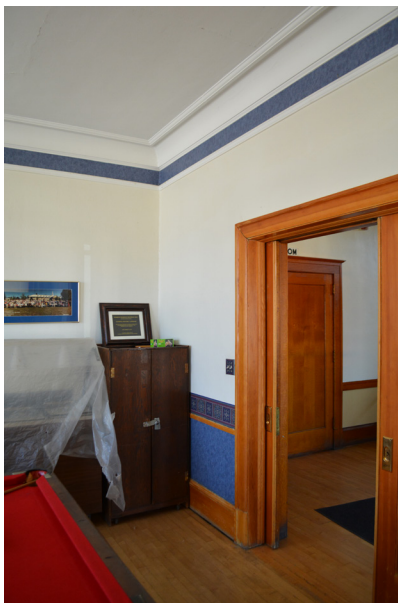
Sliding door to Parlor.

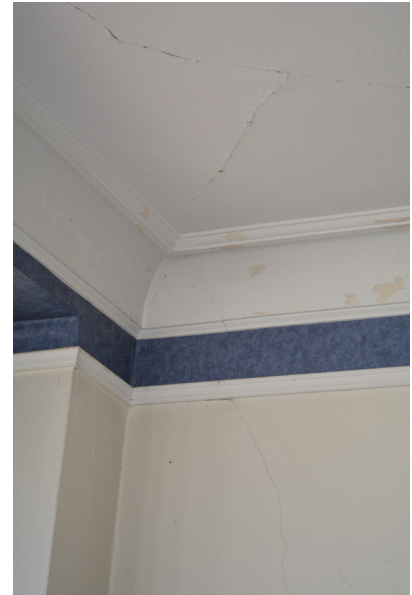
Cracks in plaster wall through the crown molding and ceiling in the Parlor.

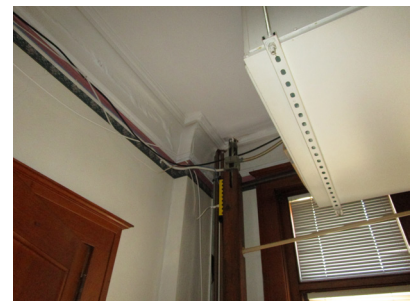
HVAC unit, exposed wires, pipes, and damaged paint on crown molding at northeast corner of Social Hall.

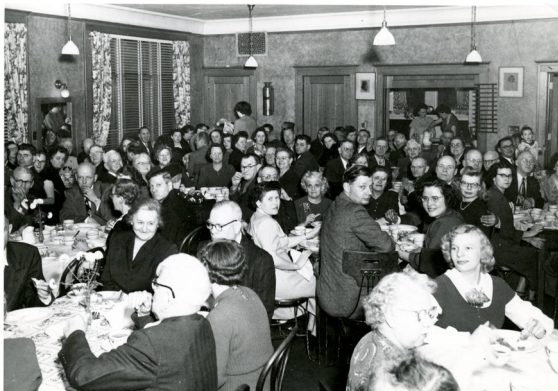
Photograph of the Social Hall and Dining Room dated circa 1950-1955.

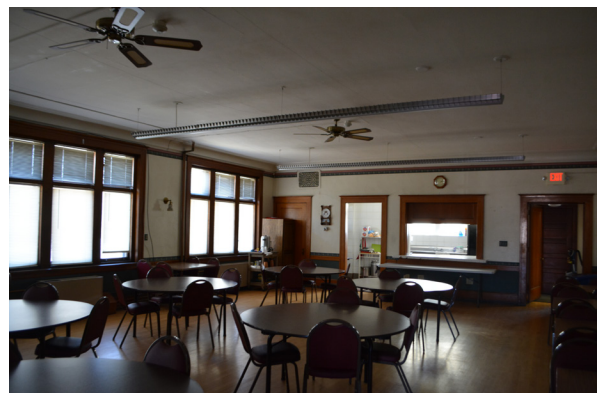
Photograph of the Social Hall and Dining Room from 2018.

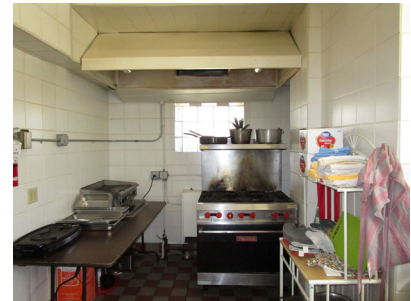
East side of first floor kitchen.

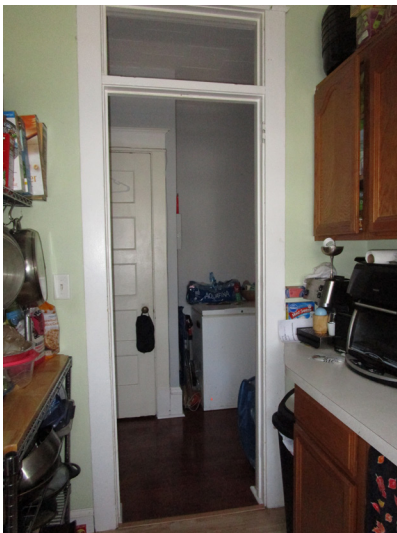
Door frame to kitchen without door.
