HISTORIC STRUCTURE REPORT

FOR CHARLES THOMPSON MEMORIAL HALL
1824 MARSHALL AVENUE | ST. PAUL, MN 55104

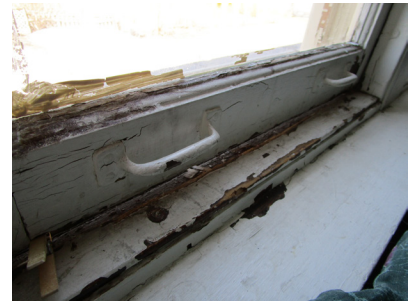
Condition of bottom of window and sill in the bedroom.

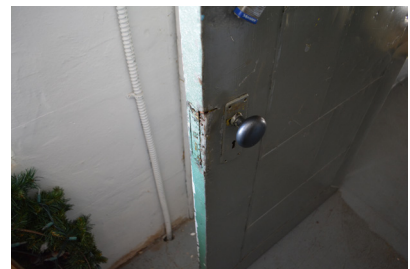
Damaged strike plate on Storage Room door.

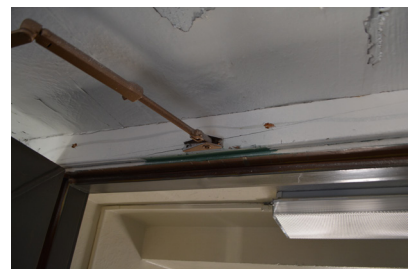
Cracks in wood casing above door.

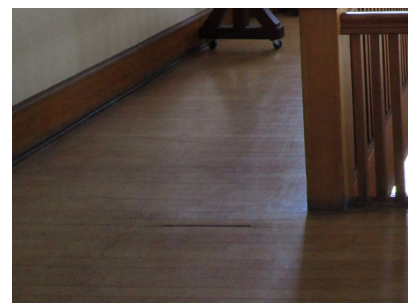
Separation of wood floor planks in second floor lobby.

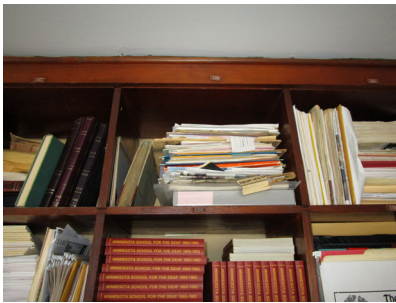
Cubbies in coat room.

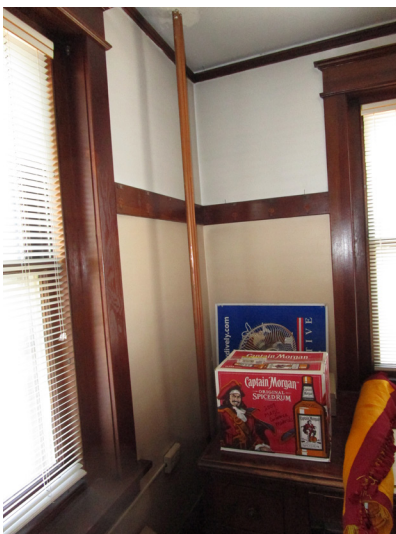
Pipe penetration in corner of Coat Room.

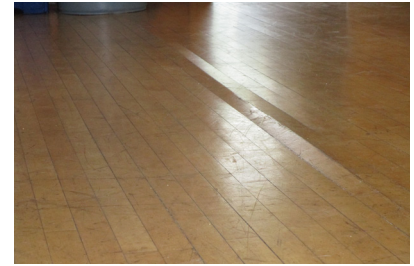
Buckling pieces of wood floor in the Assembly Hall.

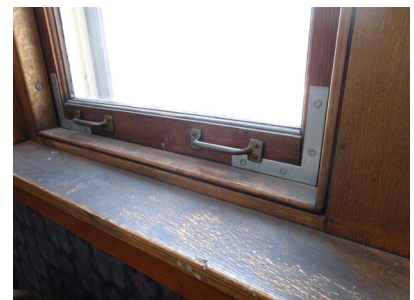
Window in the Assembly Hall which has been stabilized with metal brackets.

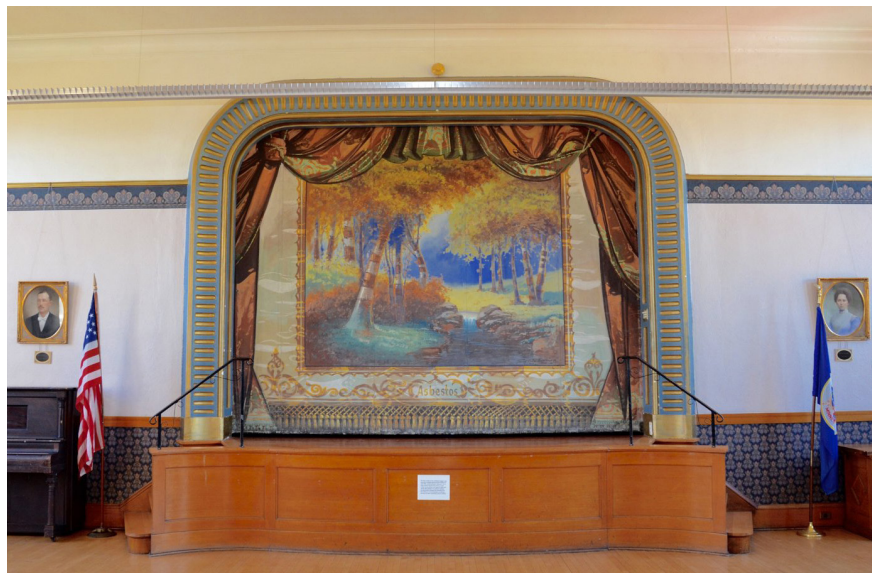
Stage, proscenium, and asbestos drop curtain.

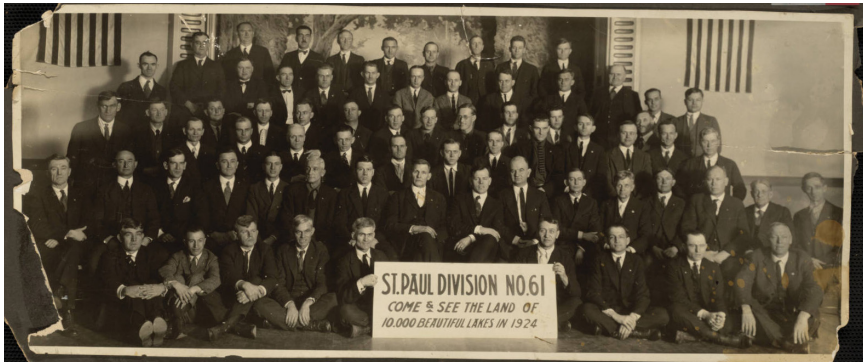
Historic photograph from 1924.

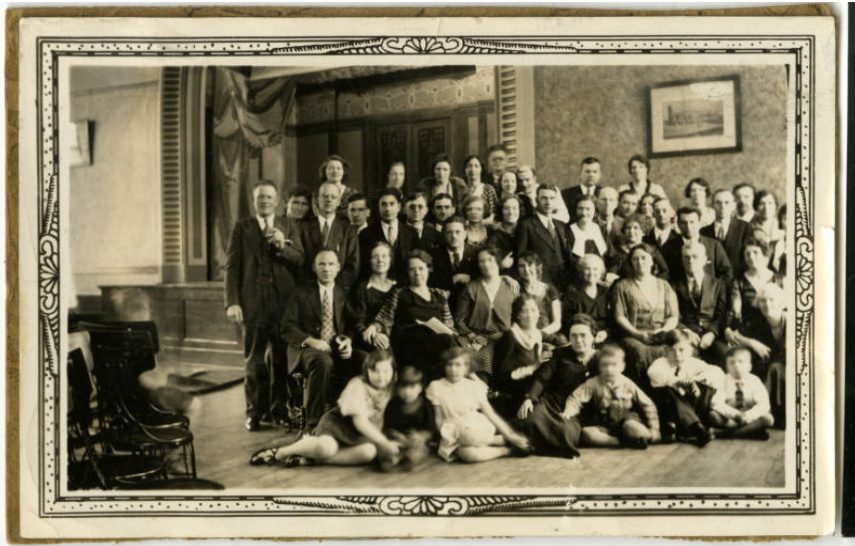
Historic photograph estimated to date between 1920 and 1930.

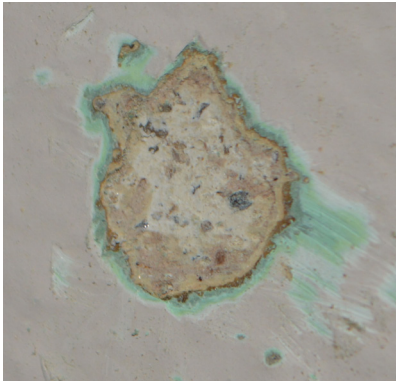
Paint sample from south wall of Assembly Hall, to the east of the stage.

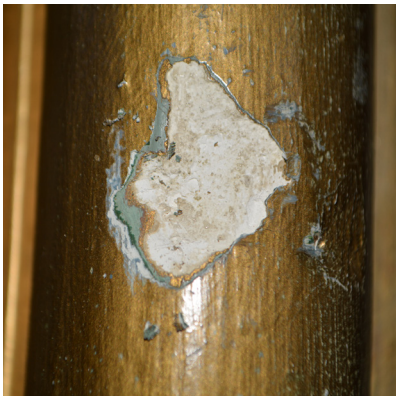
Paint sample from the rounded edge of the proscenium trim.

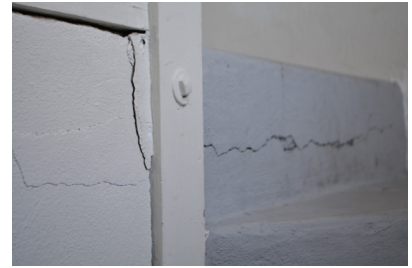
Cracks in concrete adjacent to guardrail in East Dressing Room.

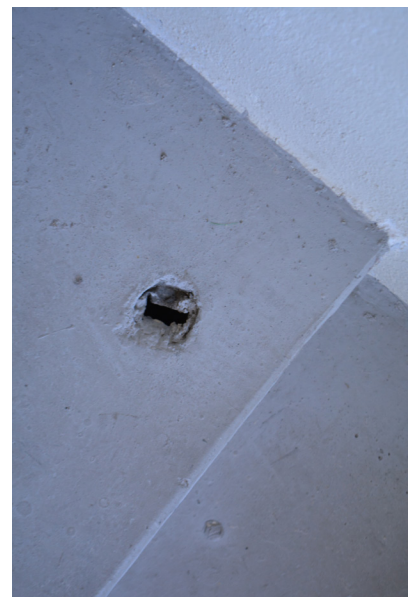
Hole in concrete at top of stairs in East Dressing Room.

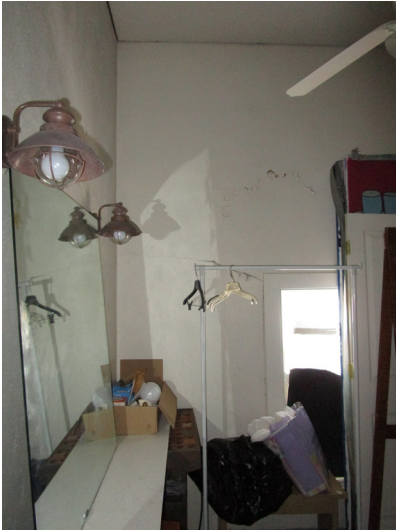
Paint failure and plaster cracks above window in West Dressing Room.

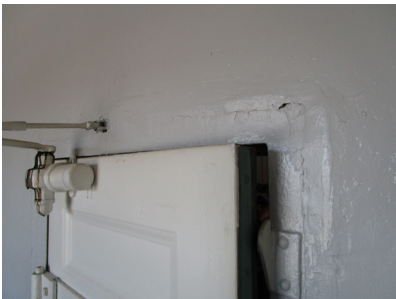
Top of projection room door and frame behind the plaster.

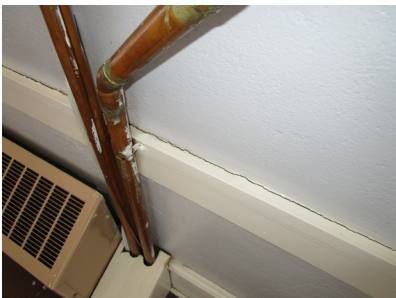
Paint cracks around boards that are pulling away in the third floor hallway.

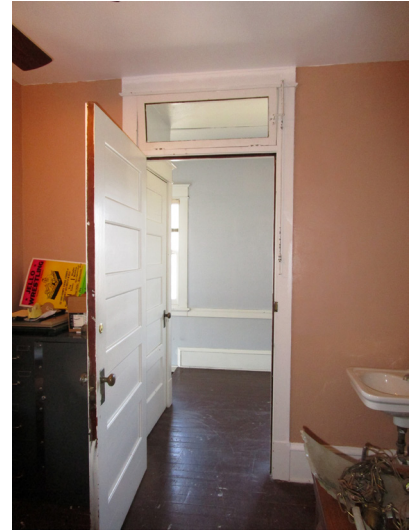
Door to small office. The sink is visible in the corner at the right of the picture.

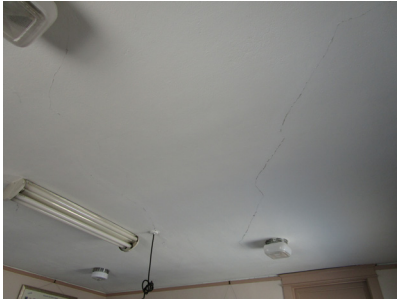
Cracks in plaster ceiling of the Printing Office.

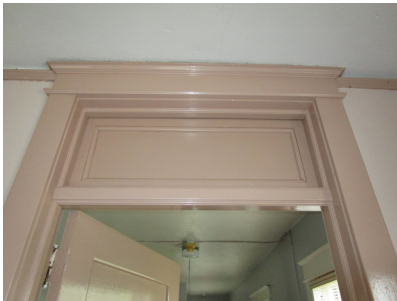
Infilled transom window above the door to the Printing Office.

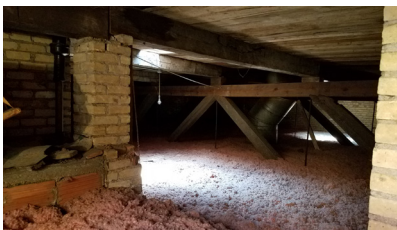
Photograph of the attic space.

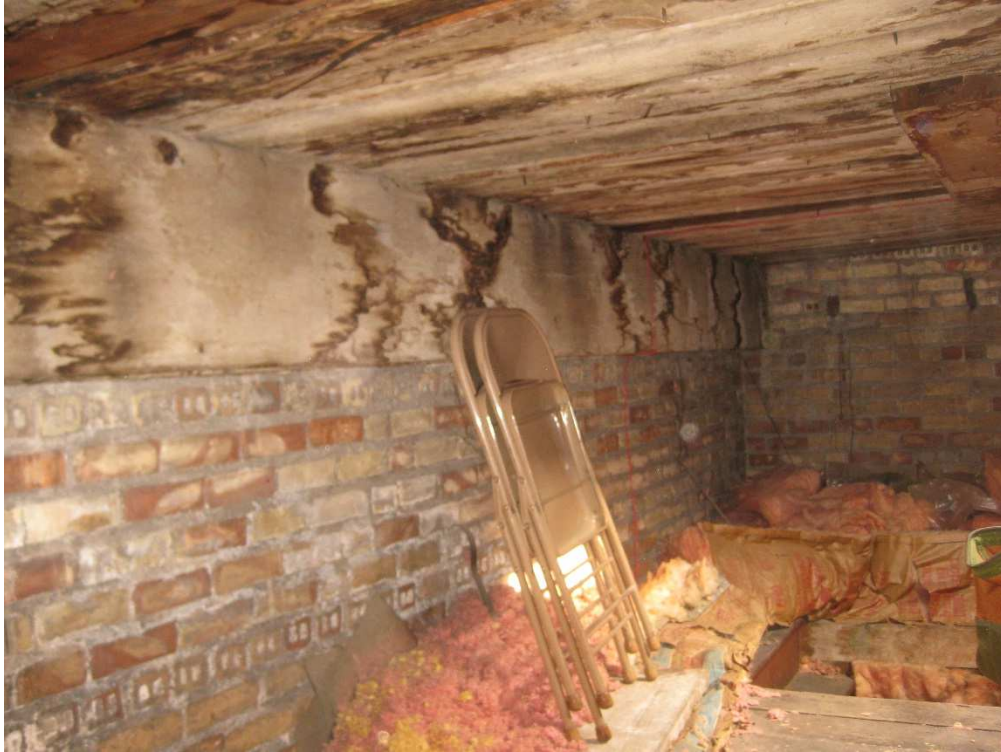
Photo 1 - Roof framing - water stains

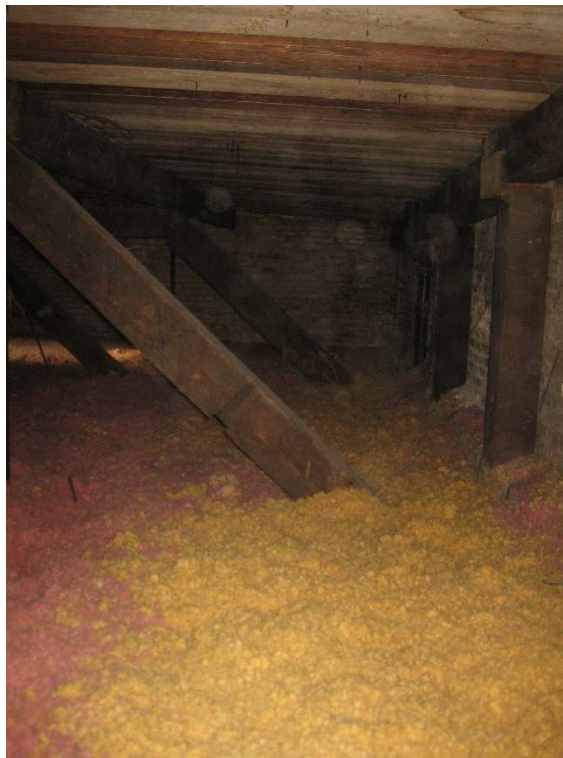
Photo 2 - Roof Framing

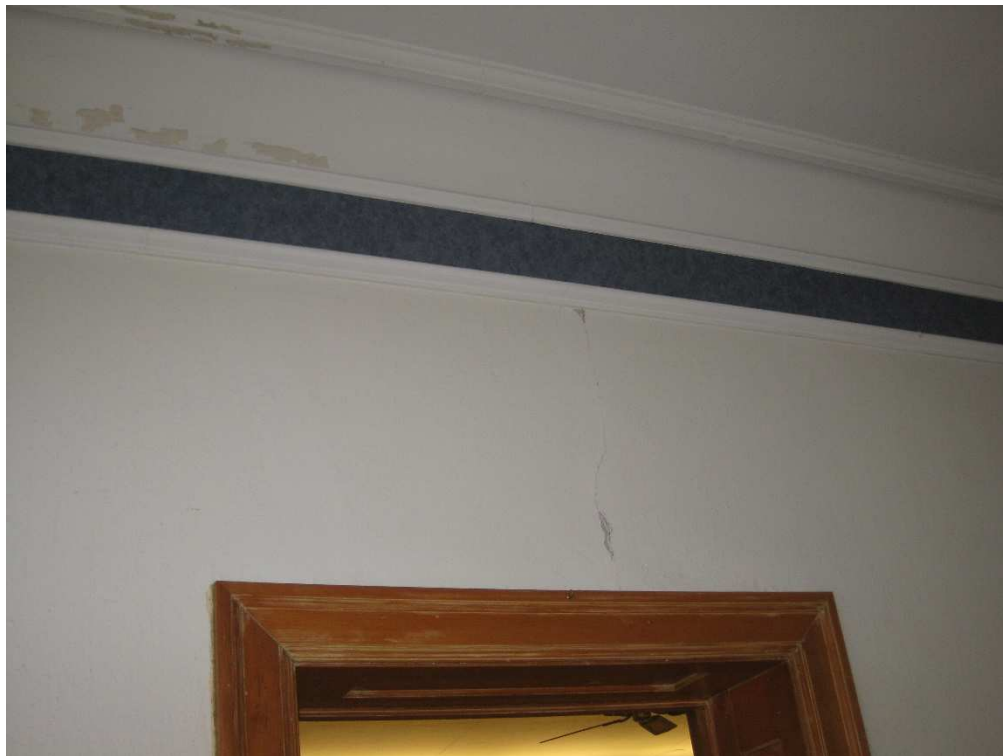
Photo 6 - Ladies Parlor - crack above door in south wall

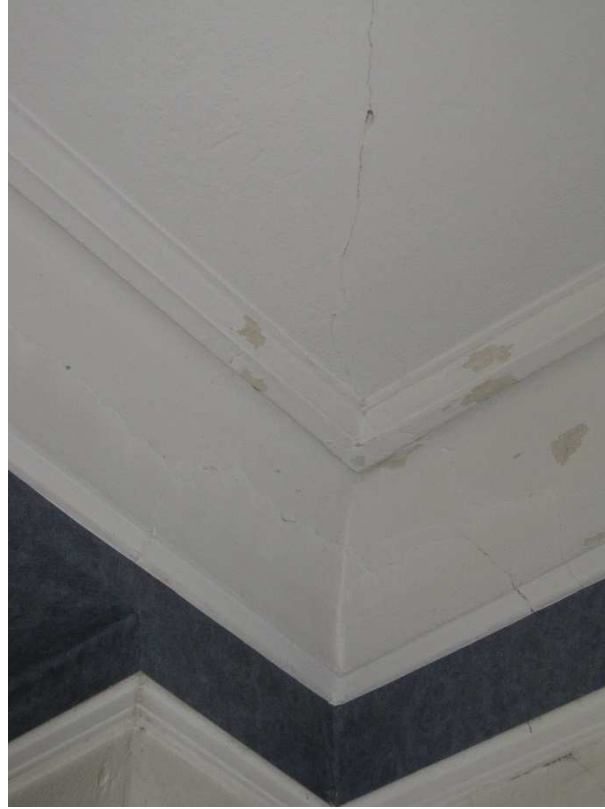
Photo 7 - Ladies Parlor - crack through crown molding

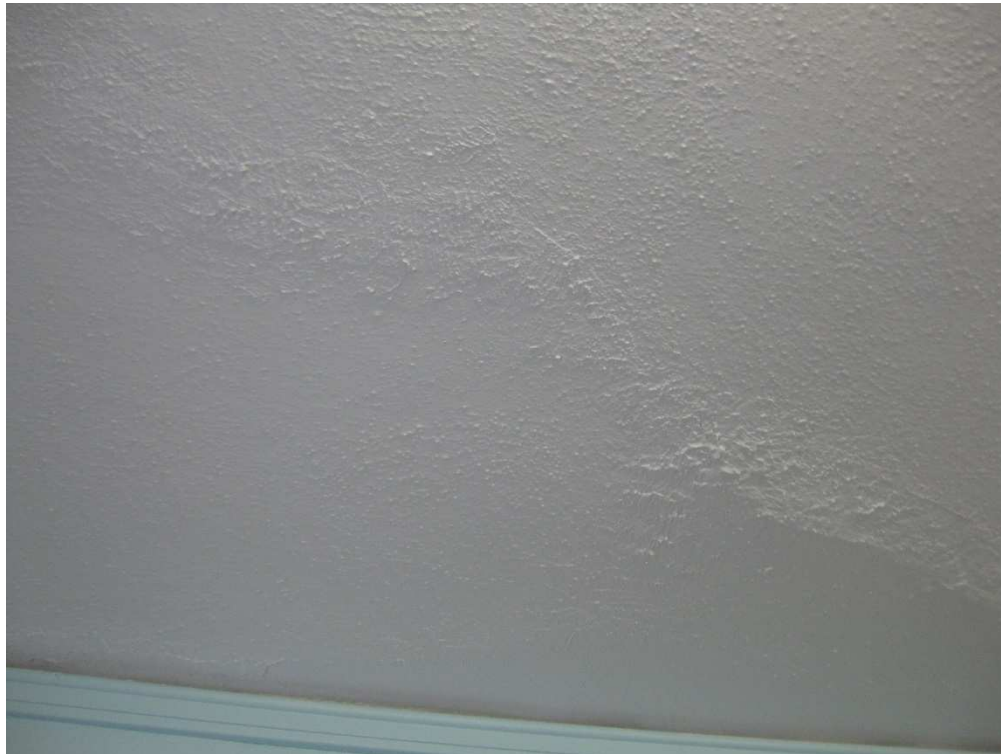
Photo 8 - Ladies Parlor ceiling - previous crack that has been patched

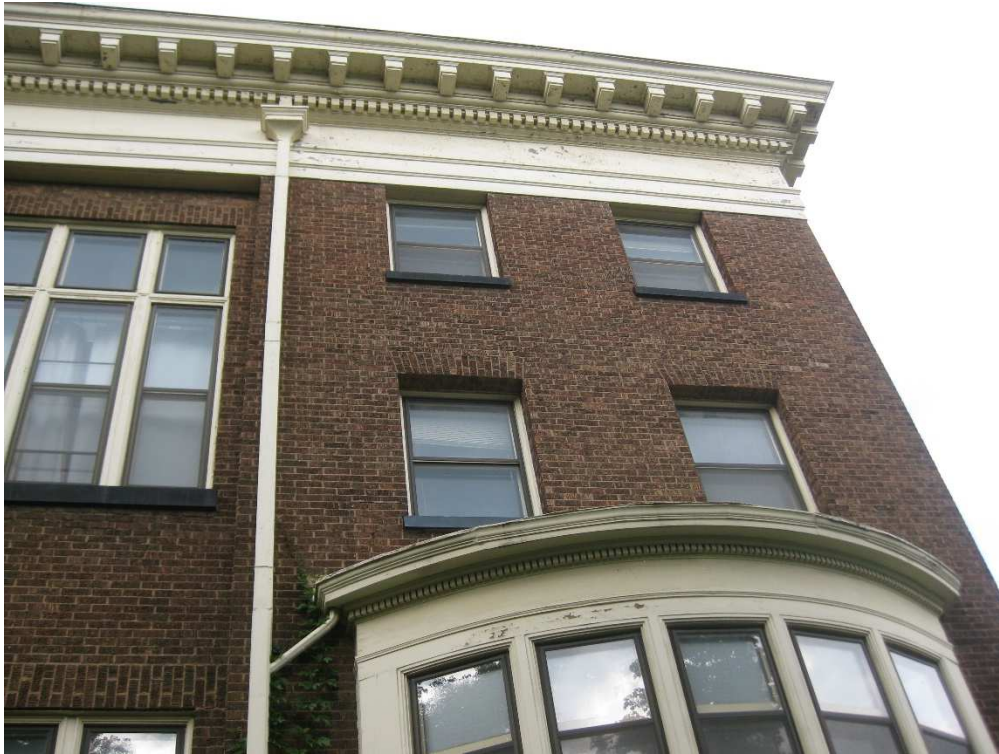
Photo 9 - East Elevation - near bow window

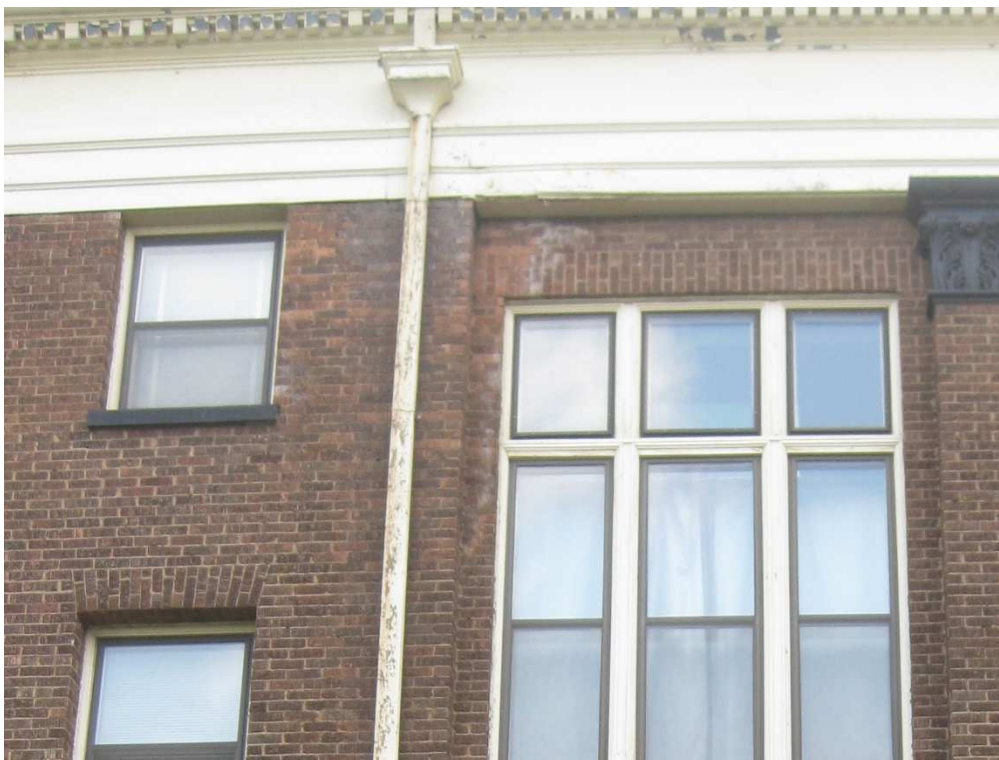
Photo 10 - West elevation showing deterioration at top of wall near downspout

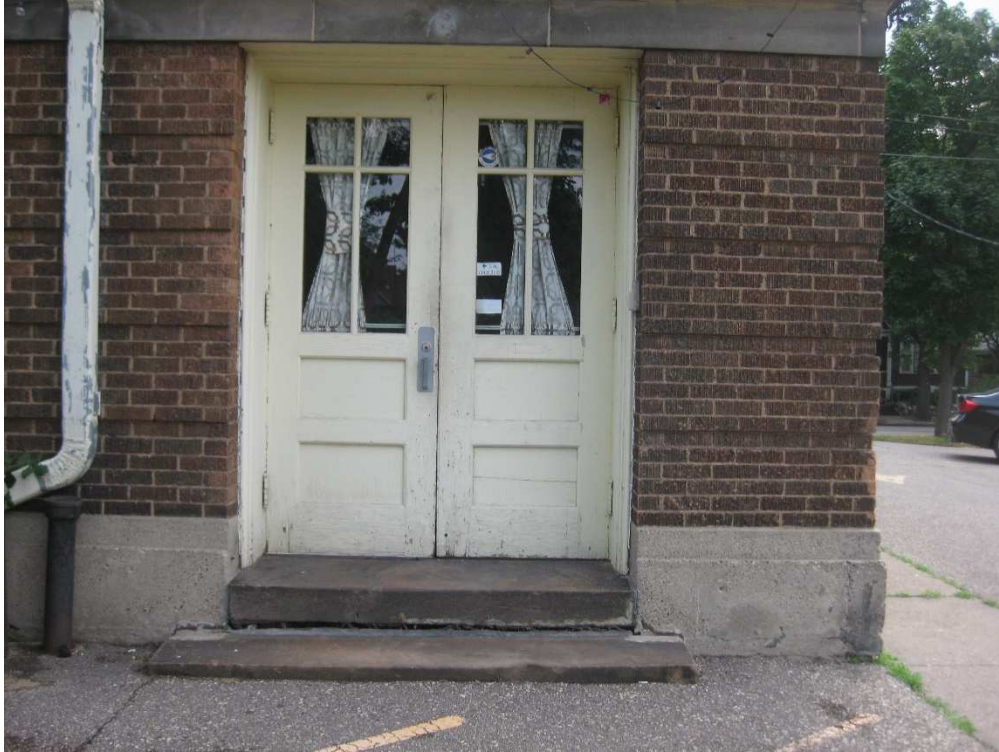
Photo 11 - West elevation - southern door

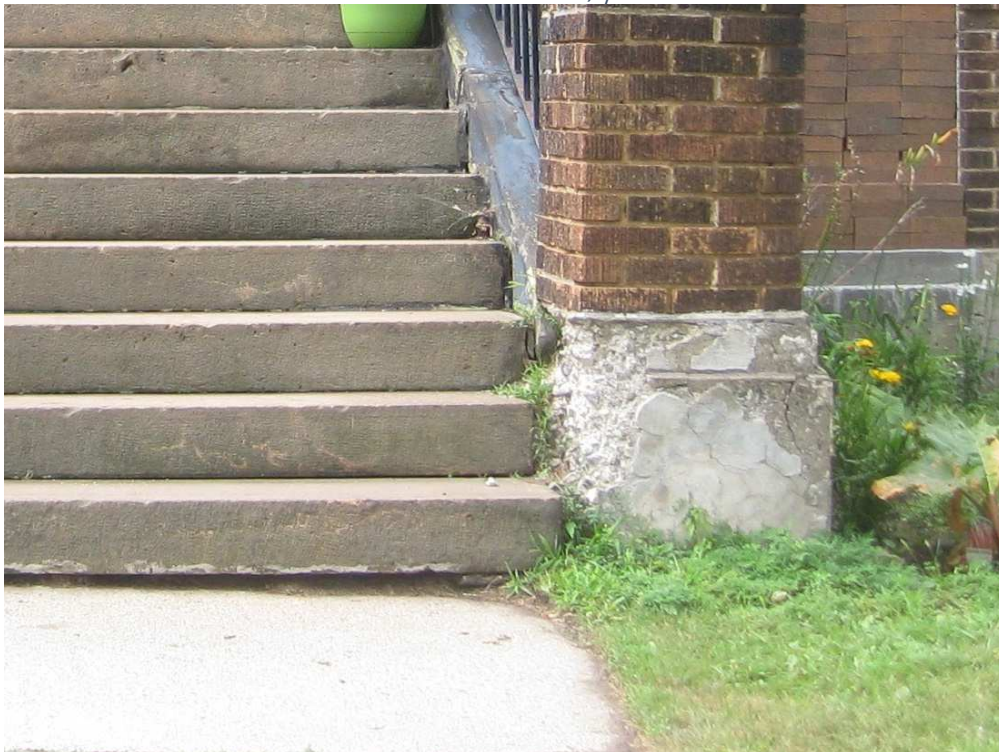
Photo 14 - Front stairs - end post deterioration and settlement of sidewalk

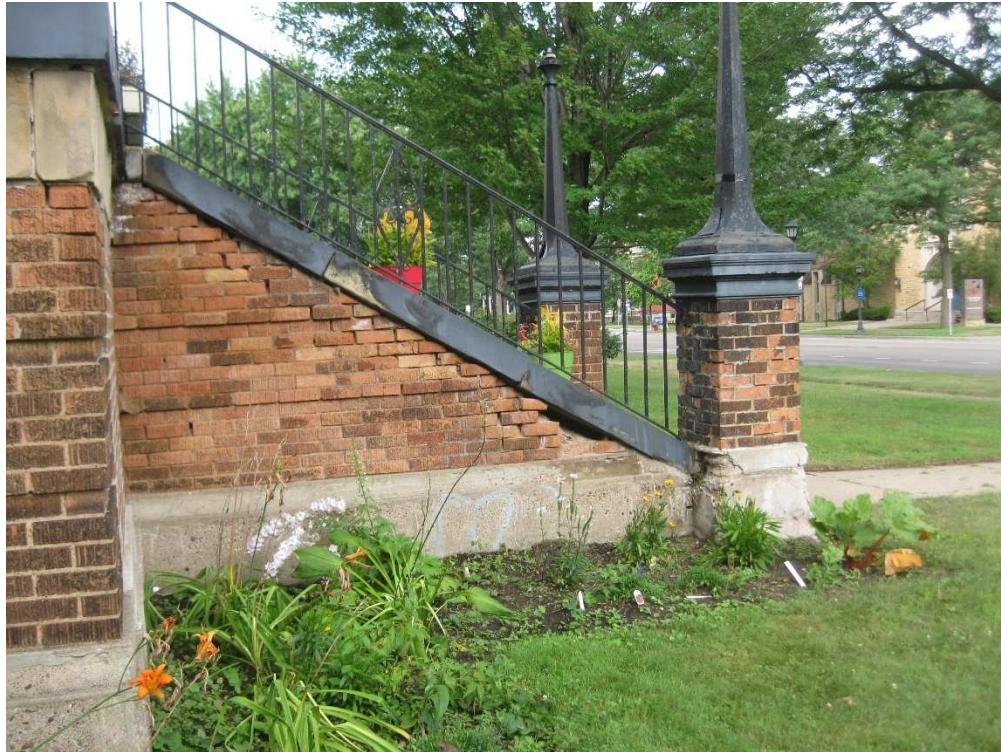
Photo 15 - Front stairs - sidewall deterioration

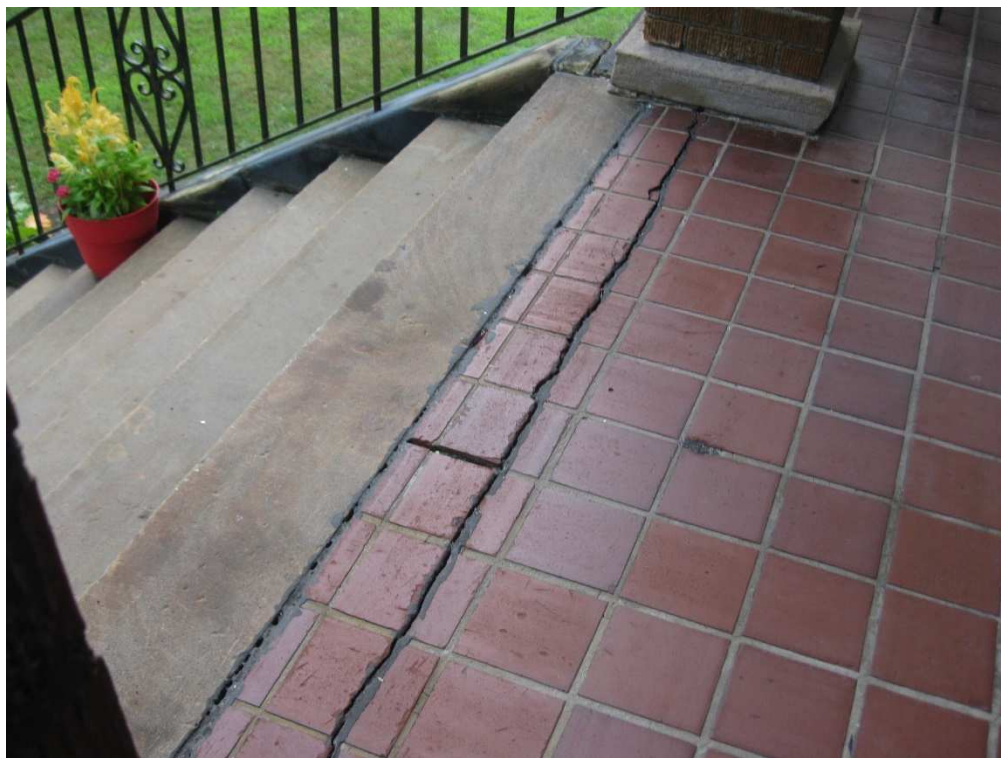
Photo 16 - Front porch - crack through tile

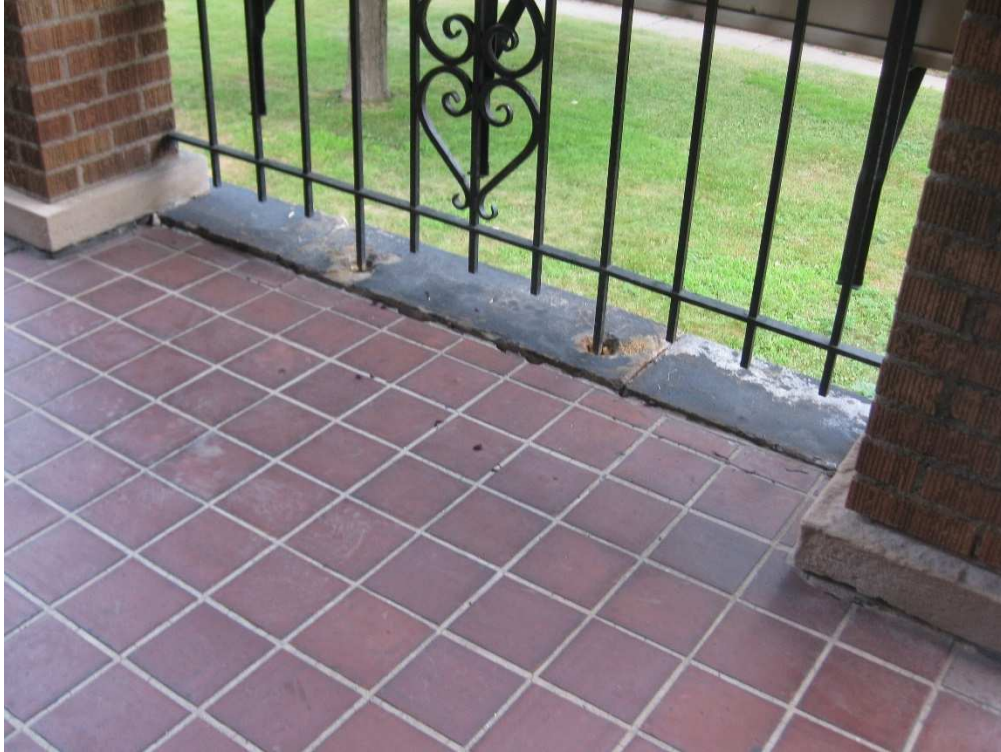
Photo 17 - Front porch - railing attachment damage

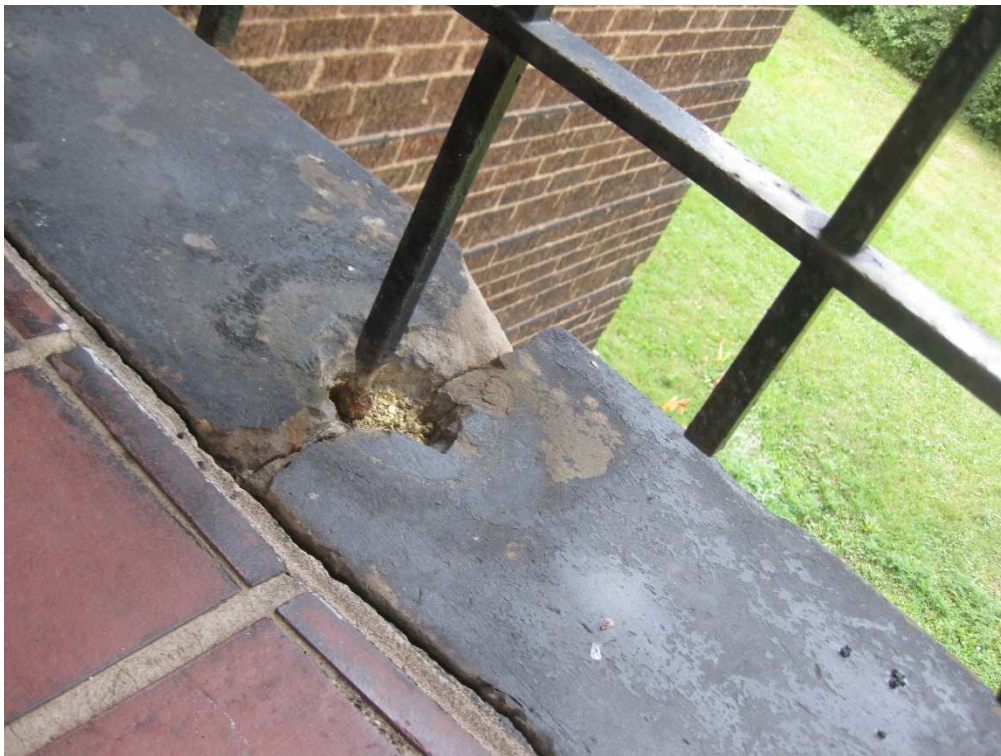
Photo 18 - Front porch - railing post deterioration
